Guidelines for the Seismic Retrofit of Existing Schools and Design of New Schools in the Republic of Armenia

APPLIED TECHNOLOGY COUNCIL

June 2017

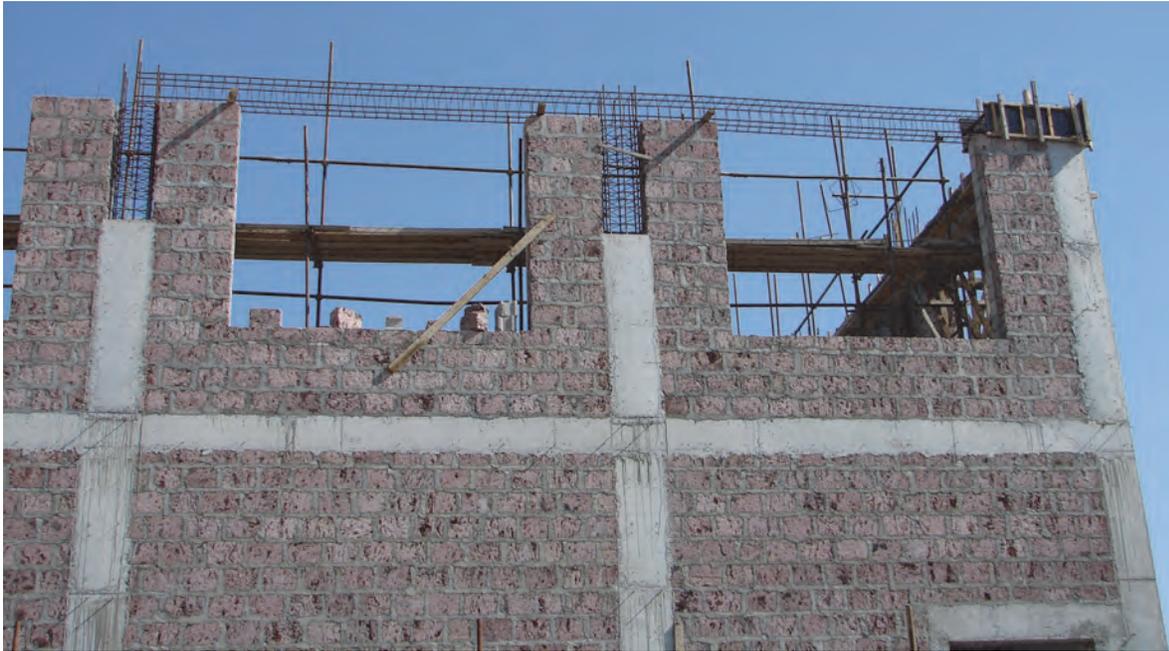
Figure 2-1 Cast-in-place reinforced concrete frame and masonry infill for a new gymnasium building under construction in Yerevan in 2016.

masonry infill walls is shown in Figure 2-1. Special detailing and connections between the masonry infill and the surrounding frame are required, but can be missing or non-existent. Interior partitions commonly consist of precast panels or blocks with minimal reinforcement sandwiched between plaster finishes. Lightweight interior partitions, including the use of steel studs and gypsum wallboard, can be found in modern commercial buildings. Construction inspection and quality control of materials, in general, is not consistent with international standards and best practices, and could be a contributing factor to poor performance of Armenian buildings in future earthquakes.

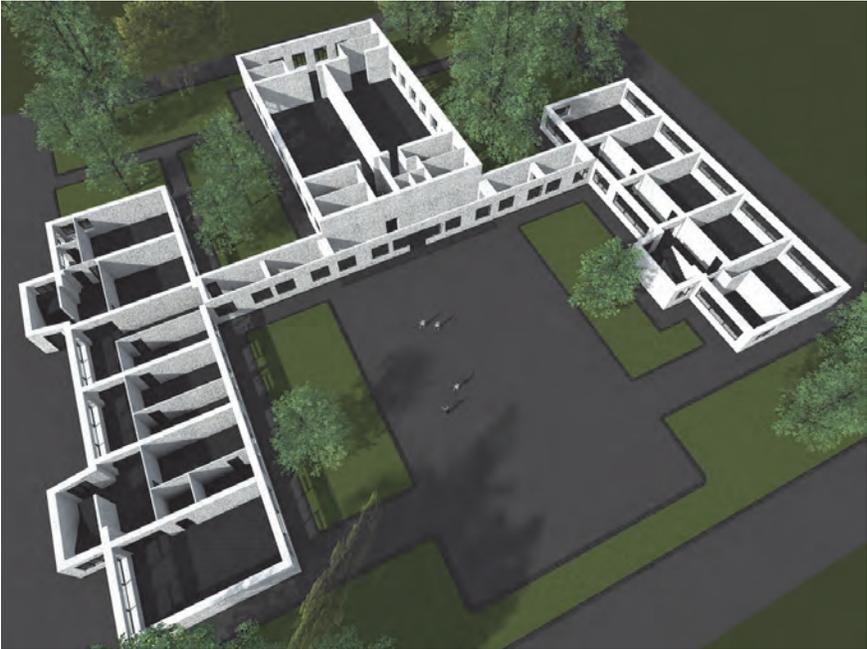
Figure 2-3 Illustration of typical school complex with multiple independent buildings, connected by corridor structures, and separated by anti-seismic joints (from EEC et al., 2015).

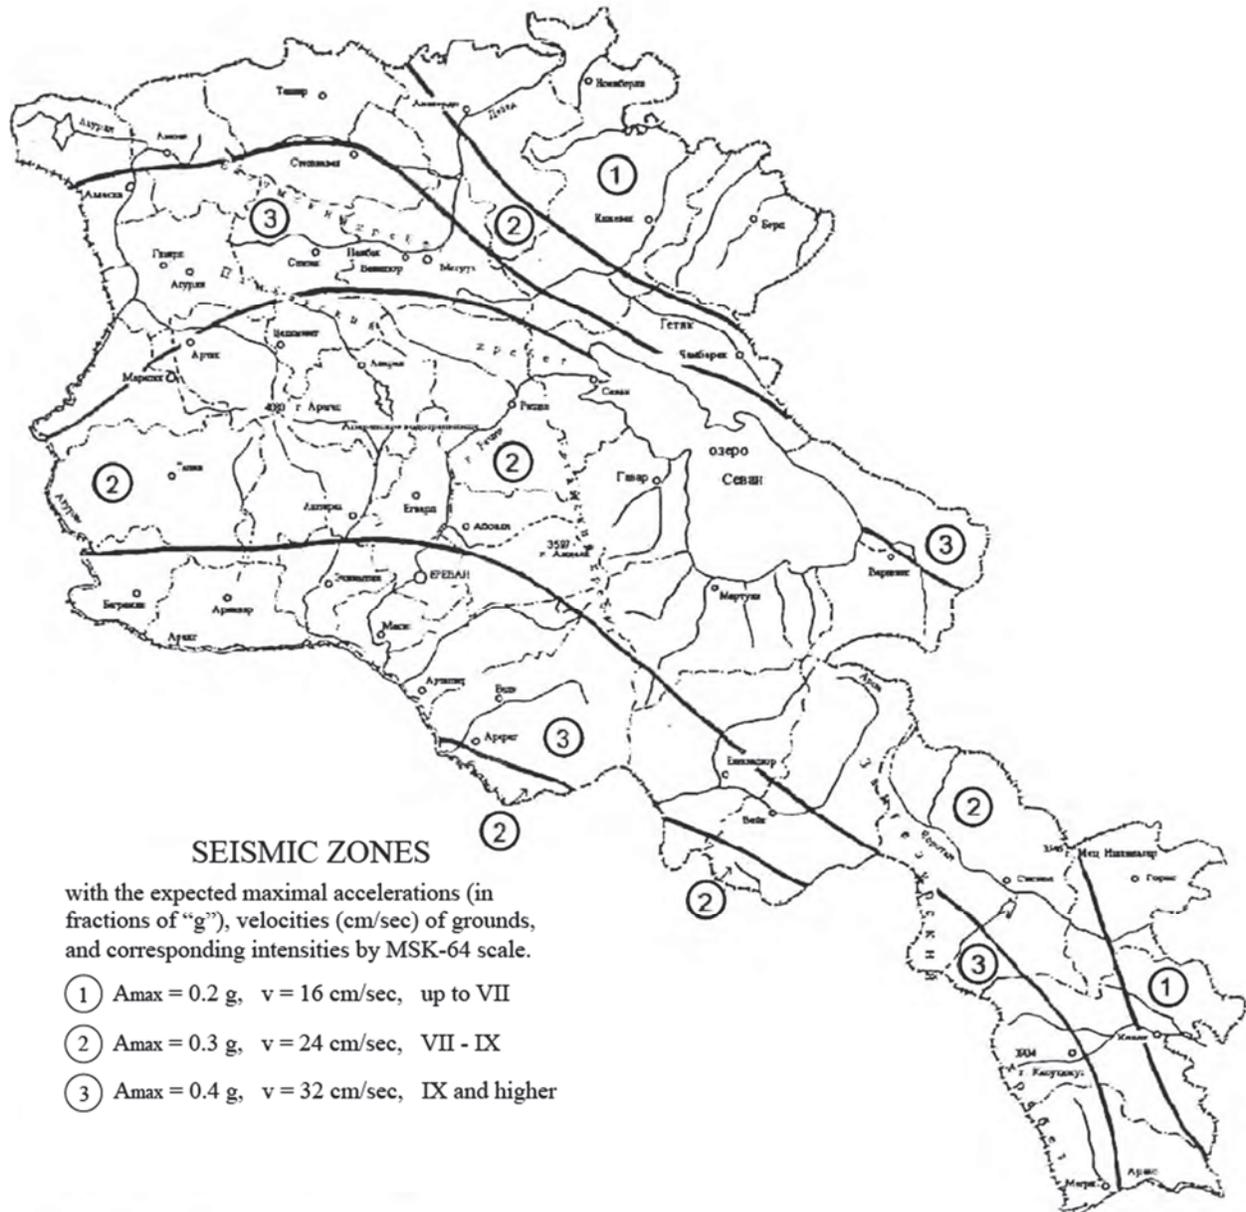
Figure 3-1 Seismic hazard map from the Armenian Building Code (Ministry of Urban Development, 2006).

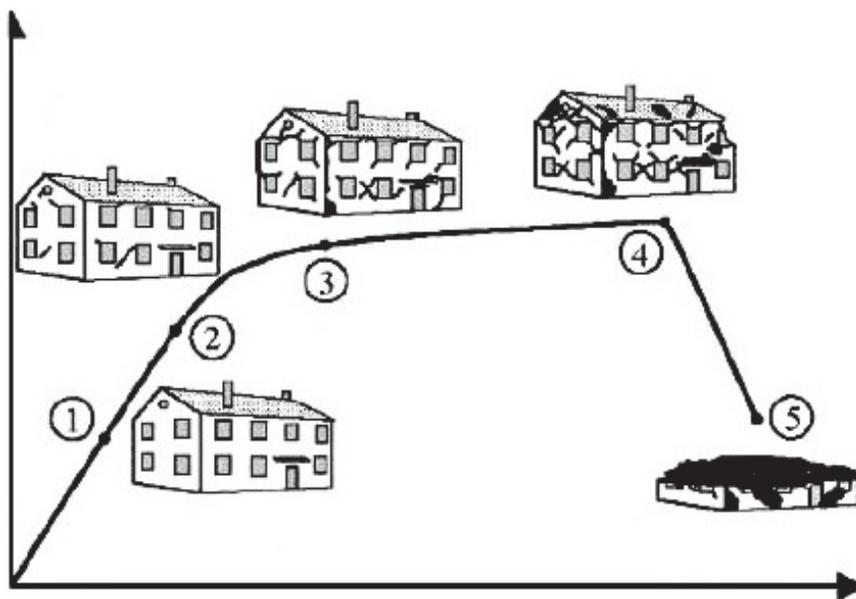
Figure 3-2 Variation of damage level with earthquake intensity (EEC et al., 2006).

Table 24 in RABC II-6.02-2006 defines five levels of building damage due to earthquakes, ranging from light damage to collapse. The expected variation of damage level with earthquake intensity is illustrated in Figure 3-2. Section 4.1 in RABC II-6.02-2006 identifies light (Damage Extent 1) and moderate (Damage Extent 2) as permissible levels of damage for buildings conforming to RABC II-6.02-2006.

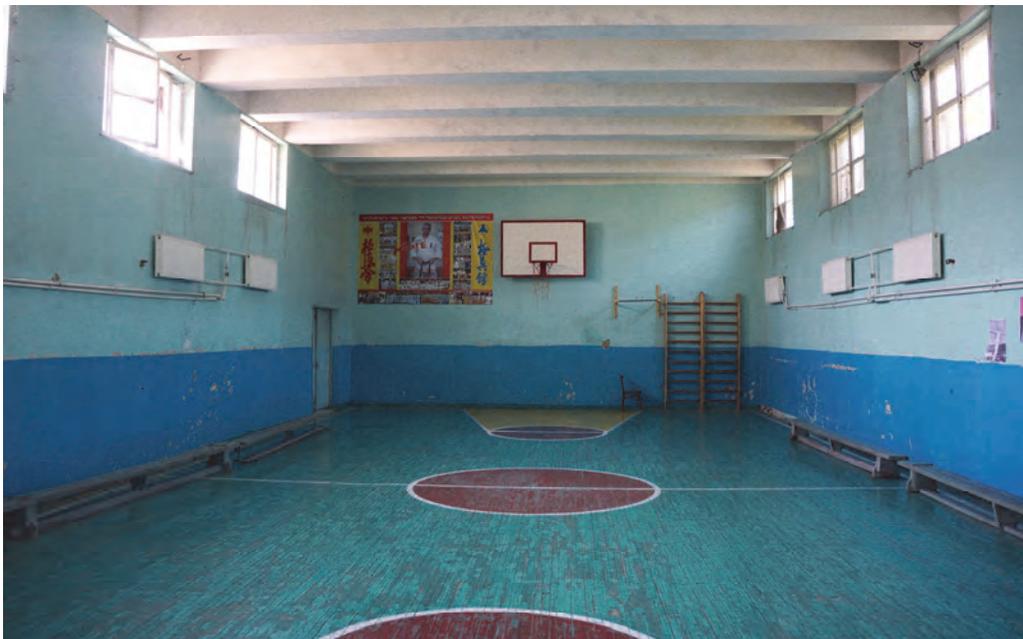
Figure 4-4 Typical Typology A gymnasium building.

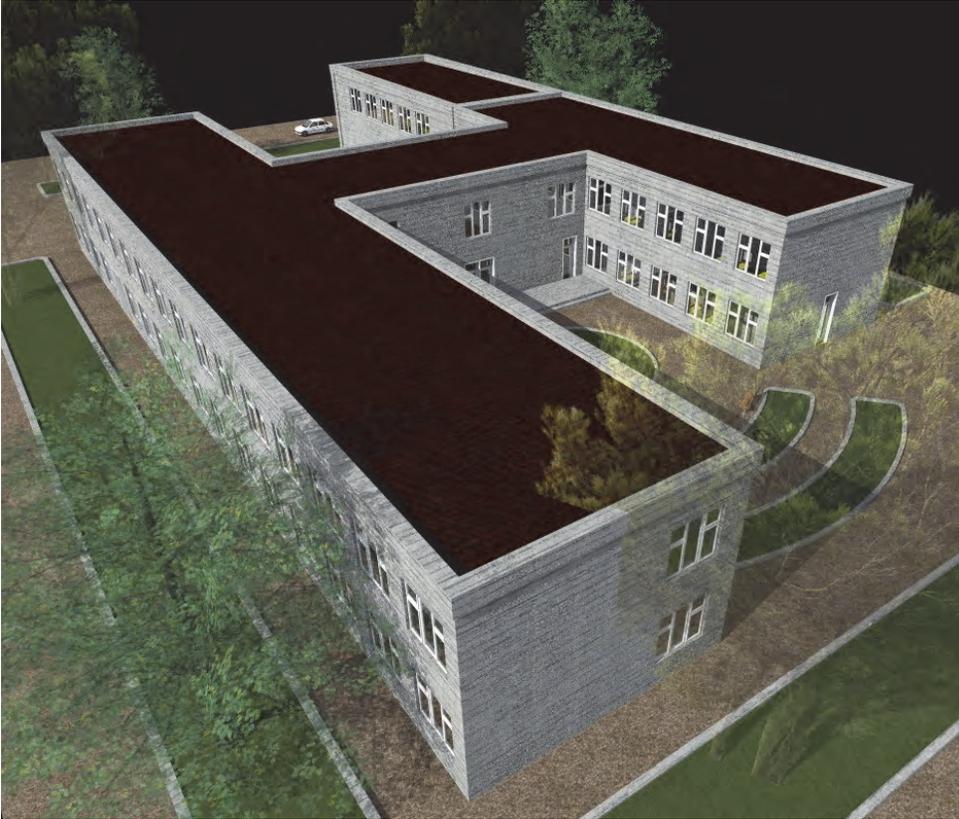
Figure 4-5 Typical Typology A school site with two buildings connected by a corridor structure (EEC et al., 2015).

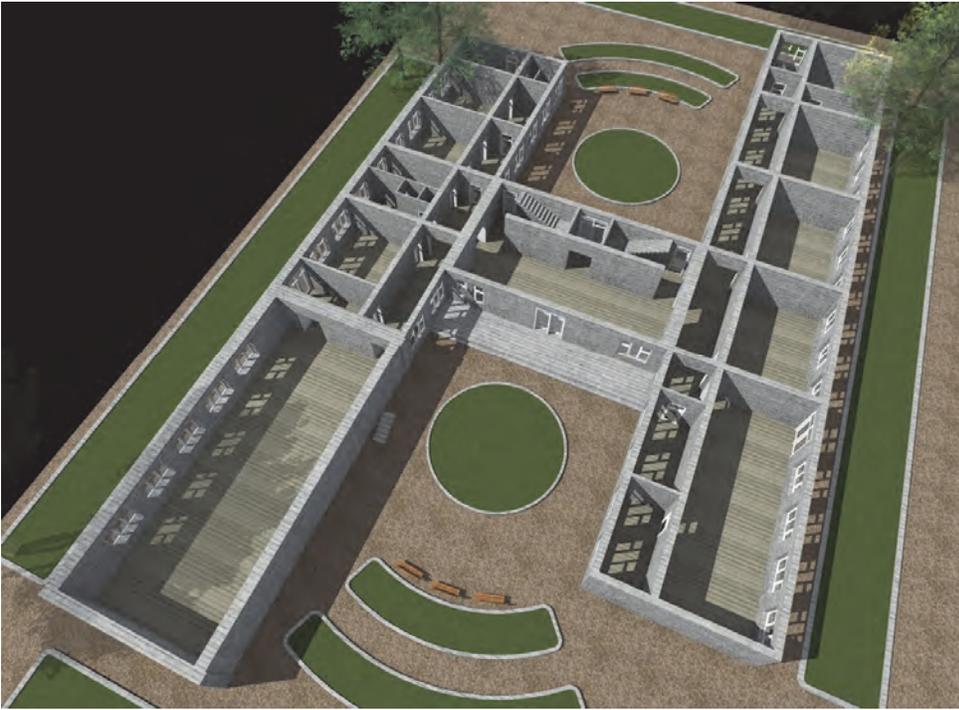
Figure 4-6 Typical wall layout for two-story Typology A school buildings (EEC et al., 2015).

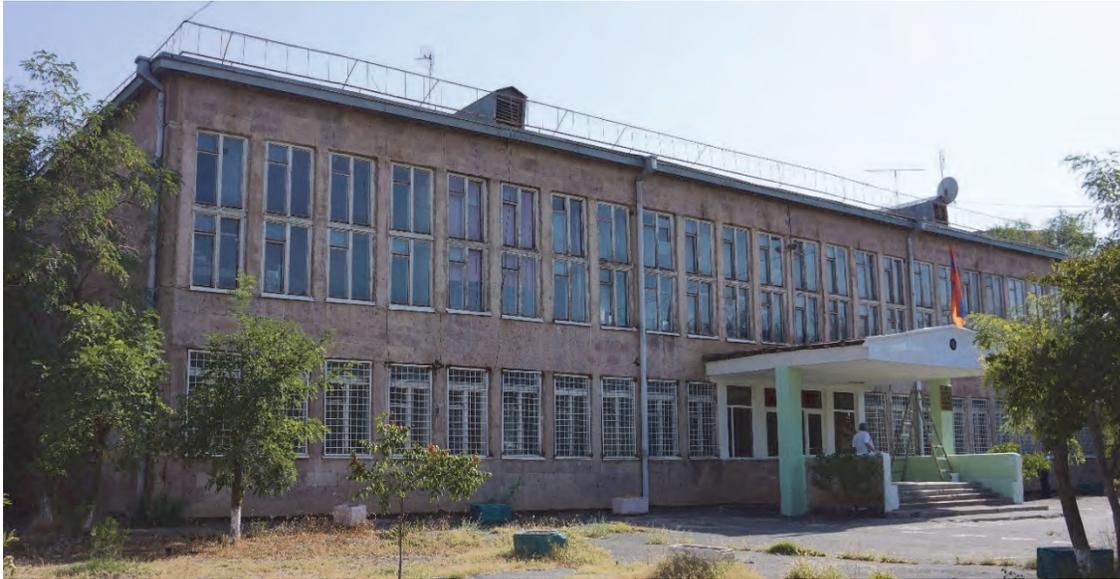
Figure 4-7 Typical two-story Typology D-1 classroom building.

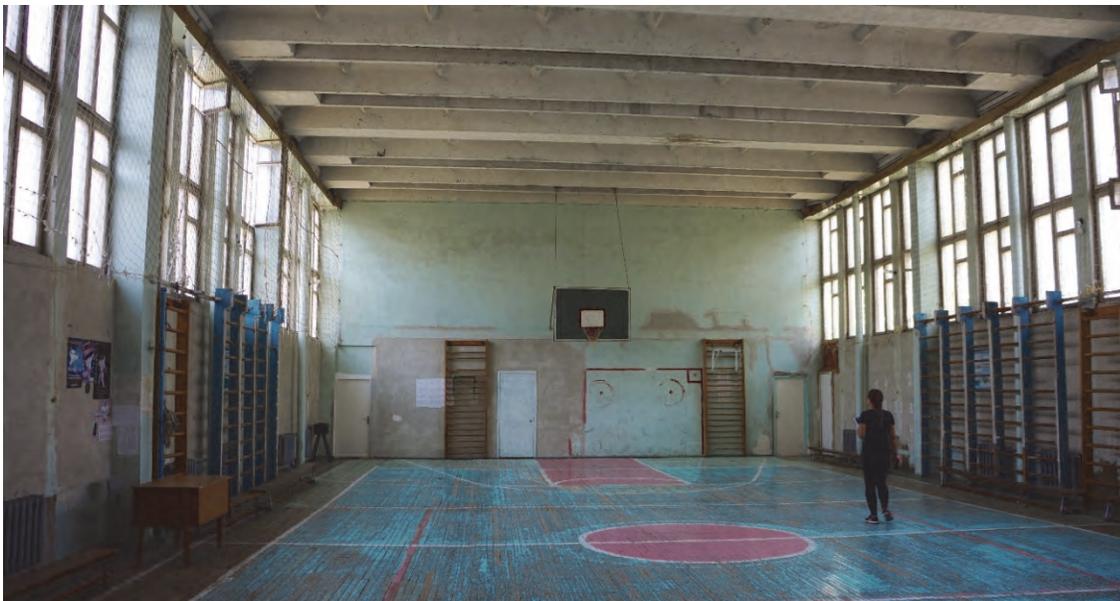
Figure 4-8 Typical Typology D-1 gymnasium building.

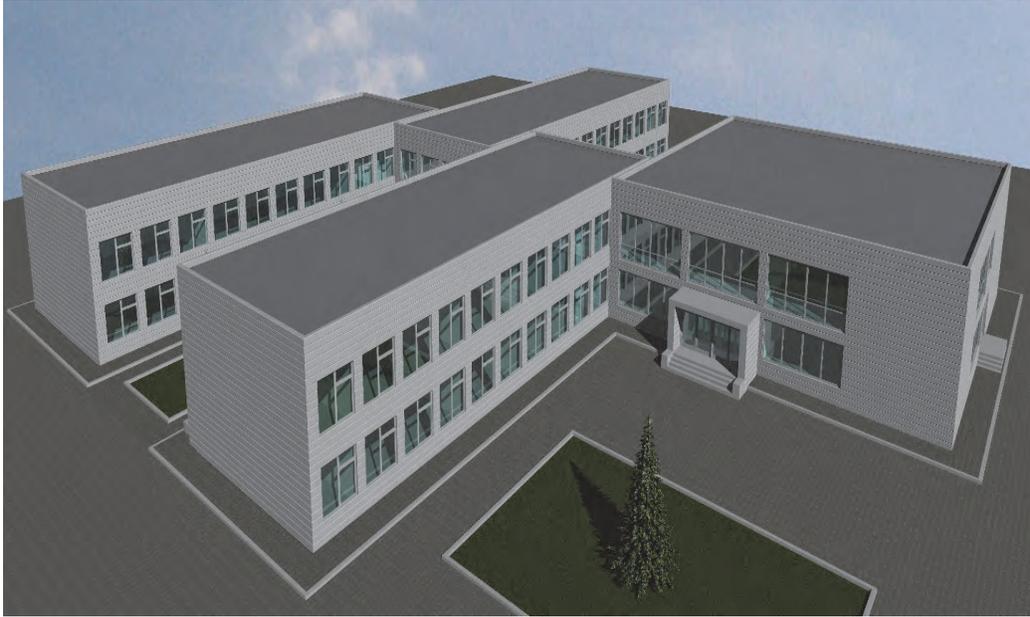
Figure 4-9 Typical Typology D-1 school site with four buildings separated by anti-seismic joints (EEC et al., 2015).

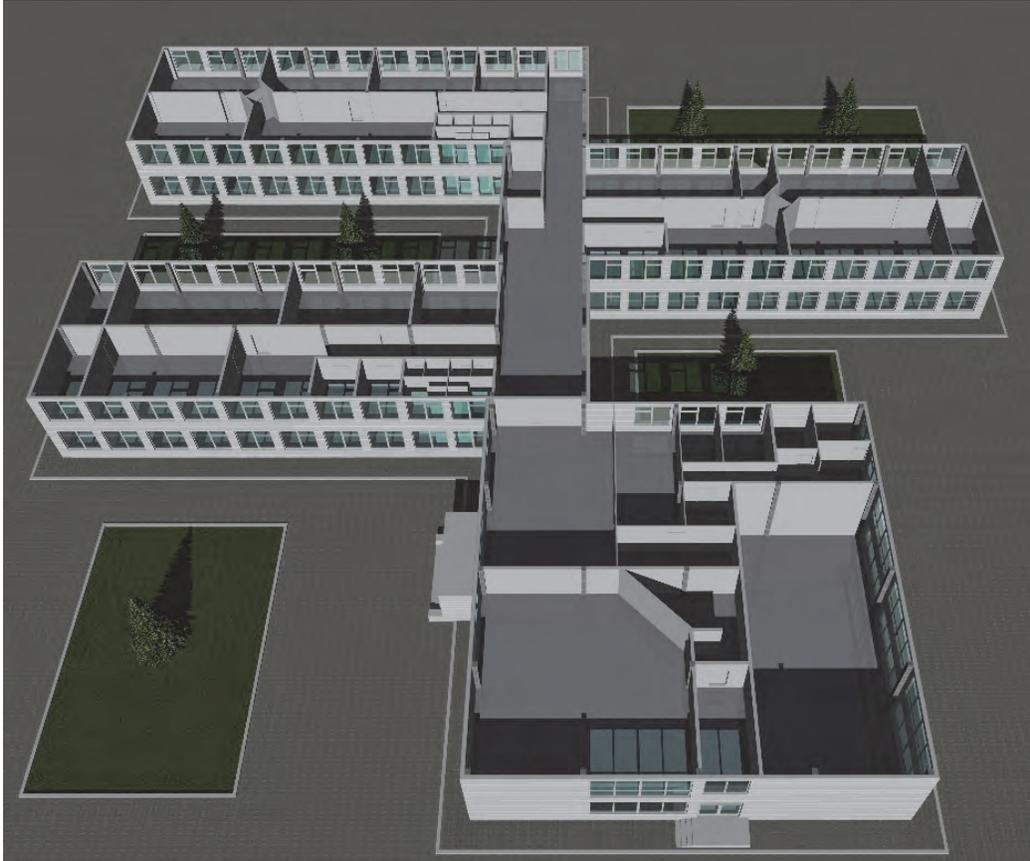
Figure 4-10 Typical wall layout for two-story Typology D-1 school buildings (EEC et al., 2015).

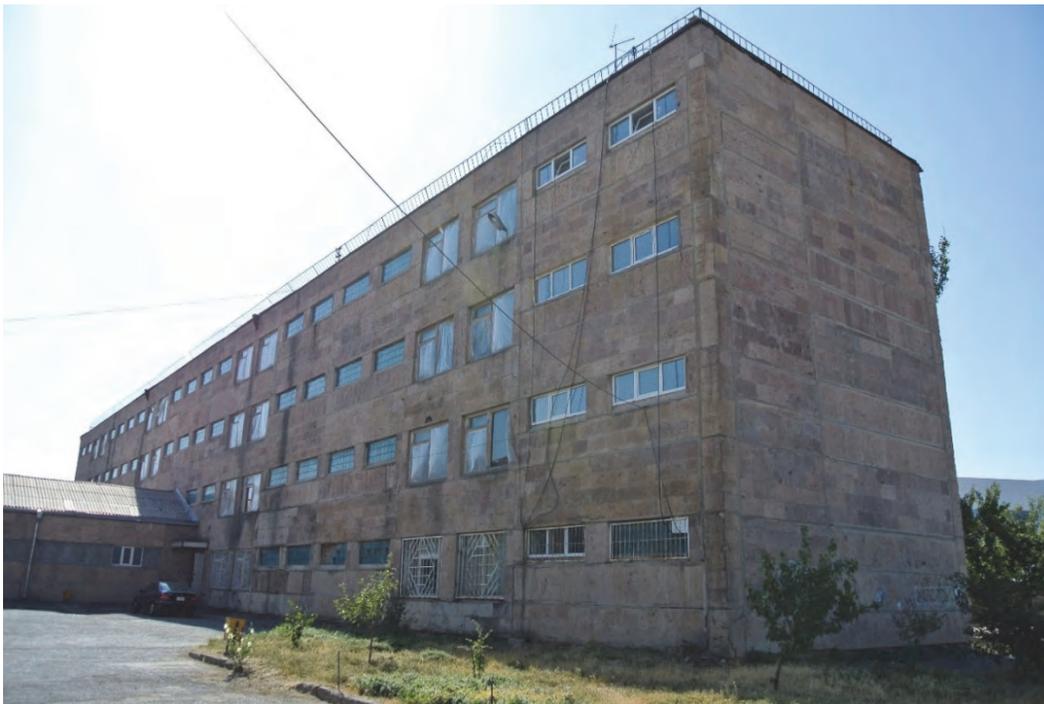
Figure 4-11 Typical four-story Typology D-2 classroom building.

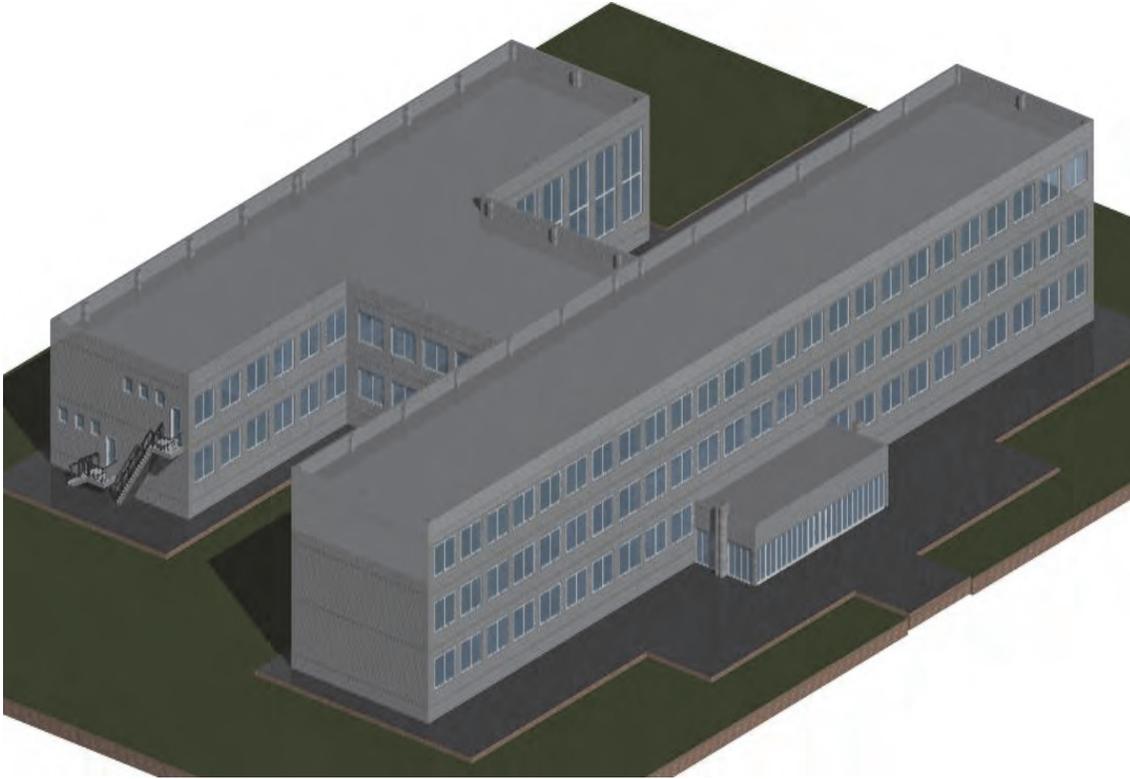
Figure 4-12 Typical Typology D-2 school site with two buildings connected by a corridor structure (EEC et al., 2015).

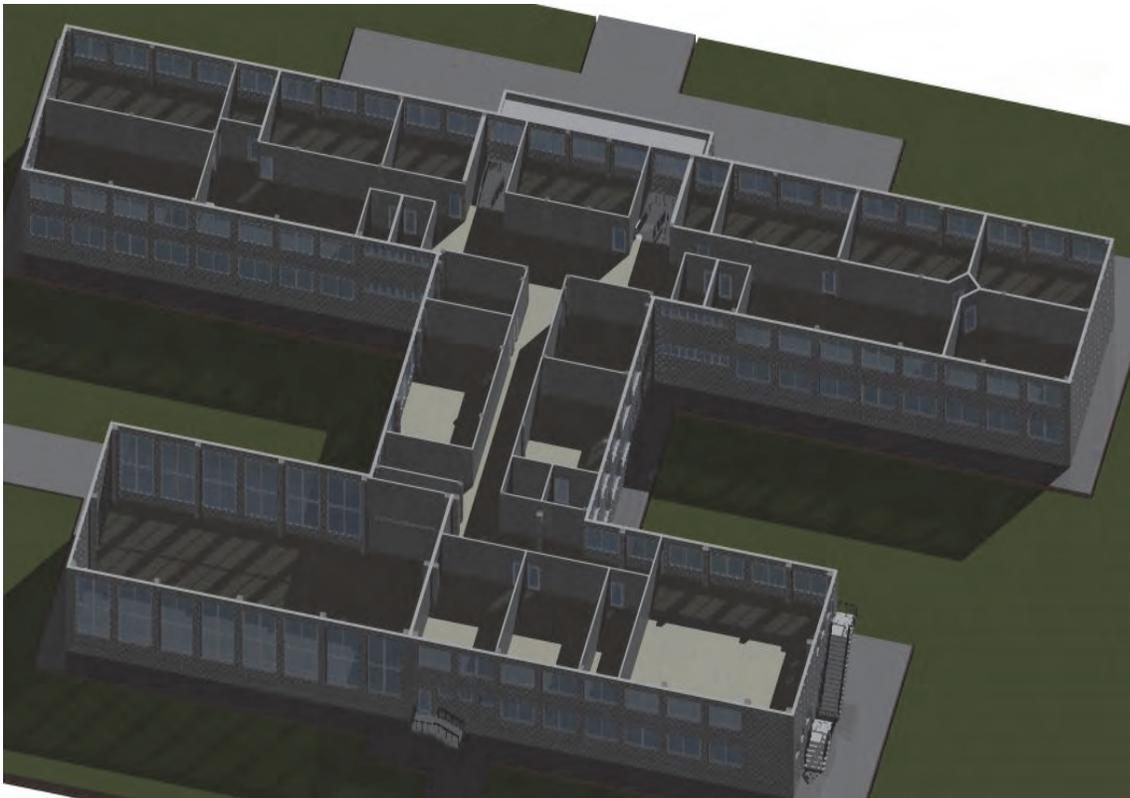
Figure 4-13 Typical wall layout for Typology D-2 school buildings (EEC et al., 2015).

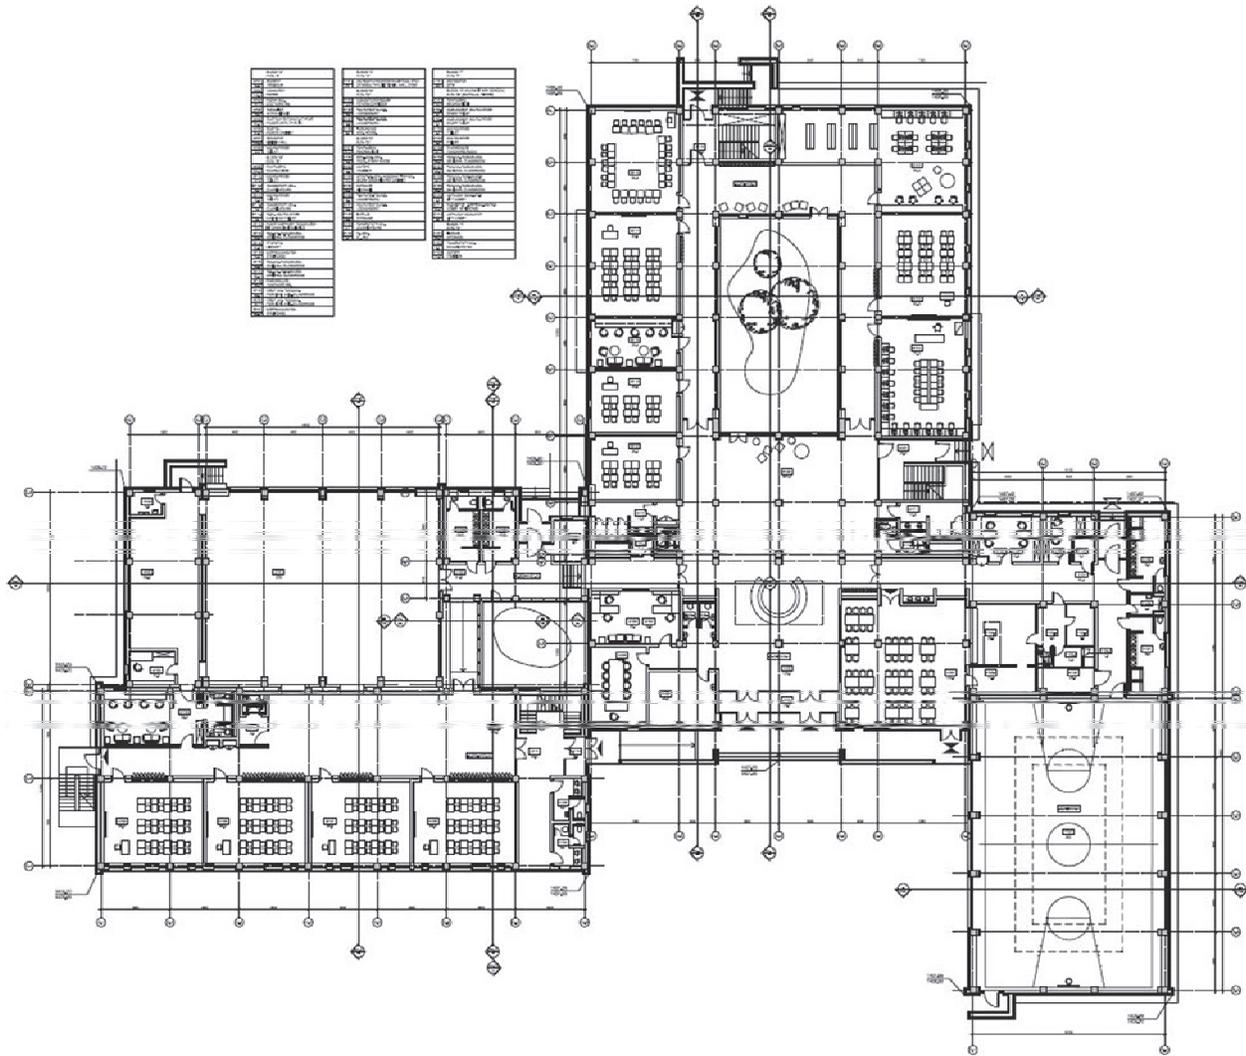
Figure 5-1 Ground floor plan of UNDP prototypical model school.

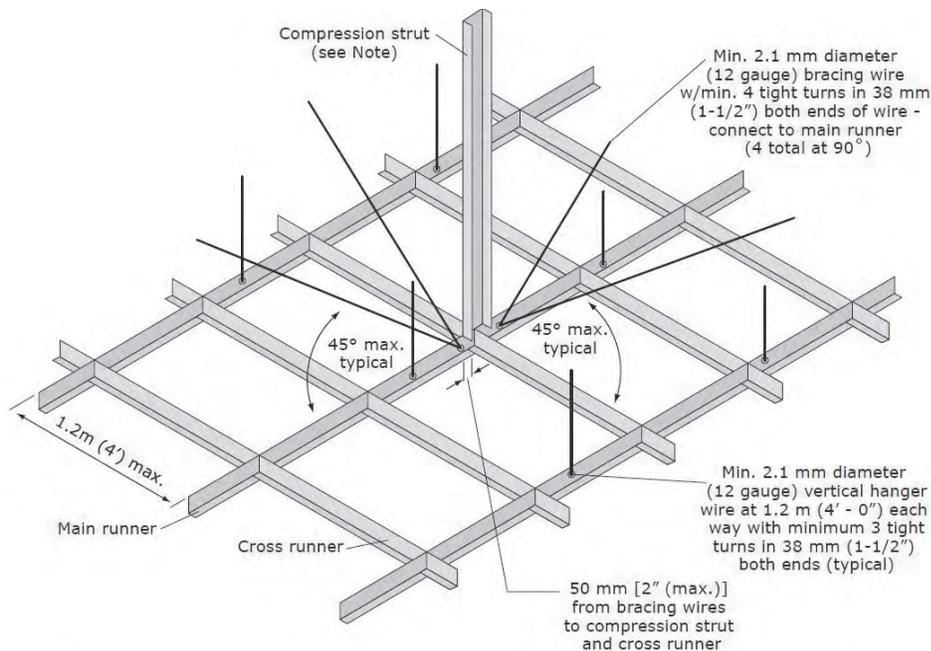
Note: Compression strut shall not replace hanger wire. Compression strut consists of a steel section attached to main runner with 2 - #12 sheet metal screws and to structure with 2 - #12 screws to wood or 6.4 mm (1/4") min. expansion anchor to concrete. Size of strut is dependent on distance between ceiling and structure ($l/r \leq 200$). A 25.4 mm (1") diameter conduit can be used for up to 1.8 m (6'), a 41 mm X 32 mm (1-5/8" X 1-1/4") metal stud can be used for up to 3 m (10').

Figure 6-1 Example of bracing for suspended ceilings (adapted from FEMA, 2012).

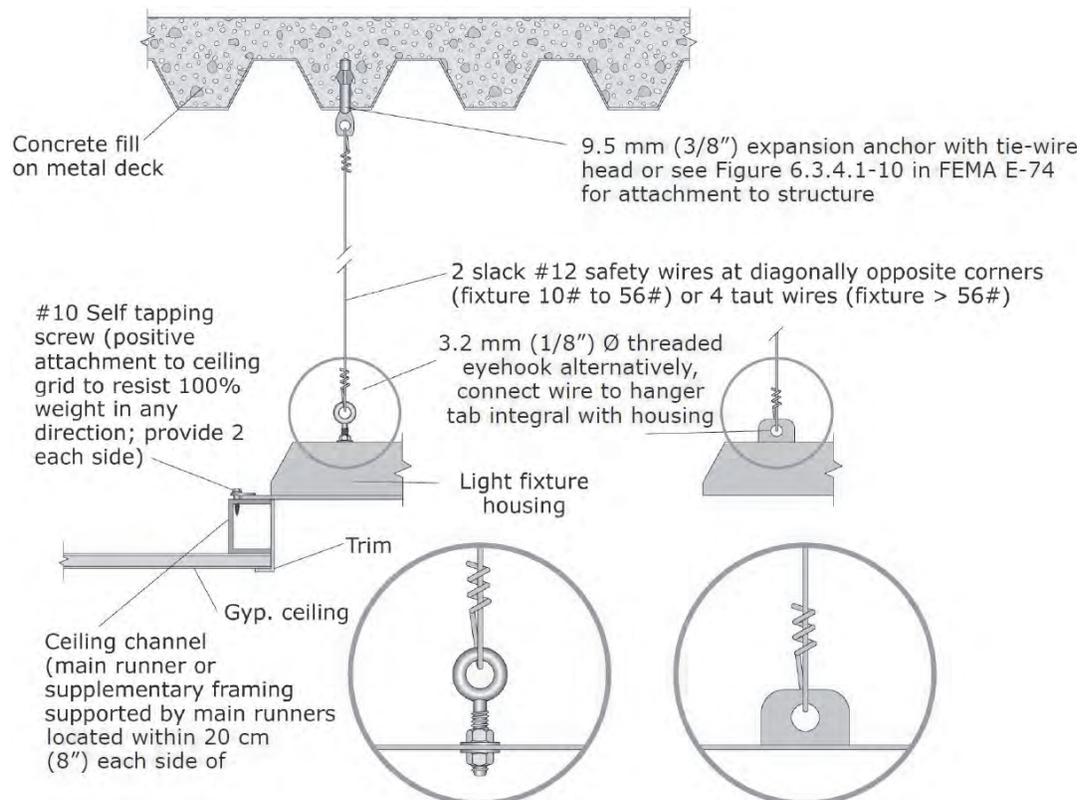
Figure 6-2 Example of recessed light fixture, 4.5 kg to 25 kg, in suspended ceiling (adapted from FEMA, 2012).

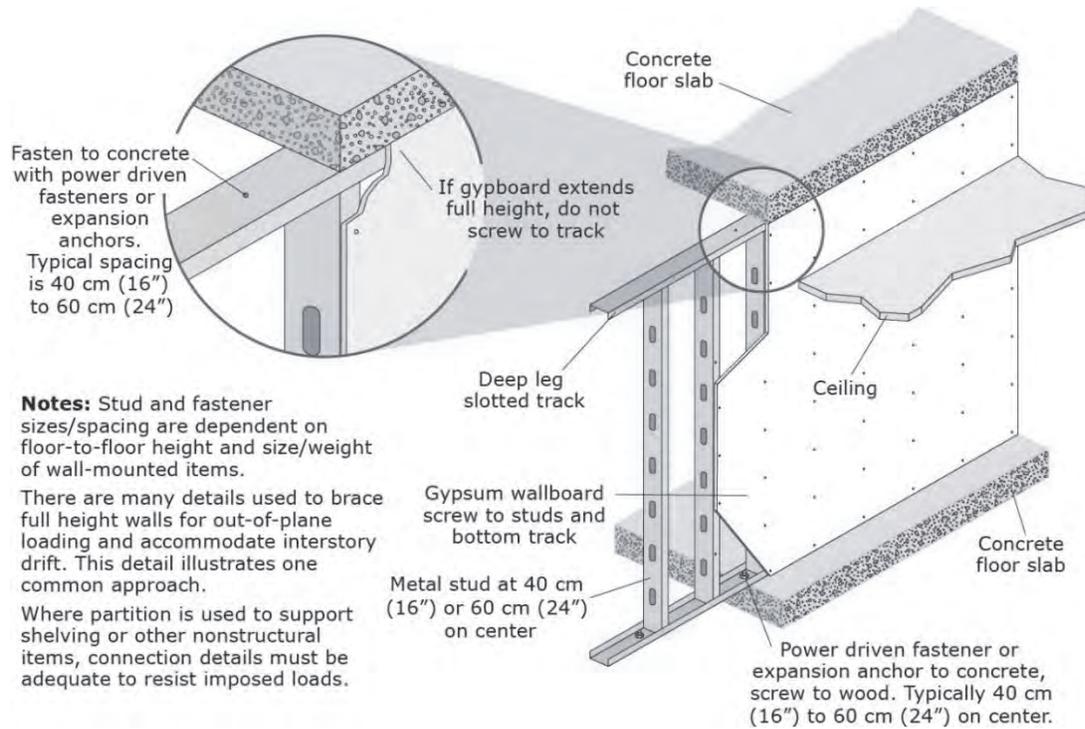
Figure 6-3 Example details for seismic attachment of non-bearing interior walls to structure (adapted from FEMA, 2012).

An example installation for full-height non-bearing steel stud walls is shown in Figure 6-3. Partitions taller than 1.8 meters in height should be laterally braced to the structure independent of any ceiling lateral bracing. In general, proper detailing at the head of the partition plays a critical role in reducing the severity of earthquake damage. More details on nonstructural interior partition attachments can be found in Section 6.3.2 of FEMA E-74 (FEMA, 2012).

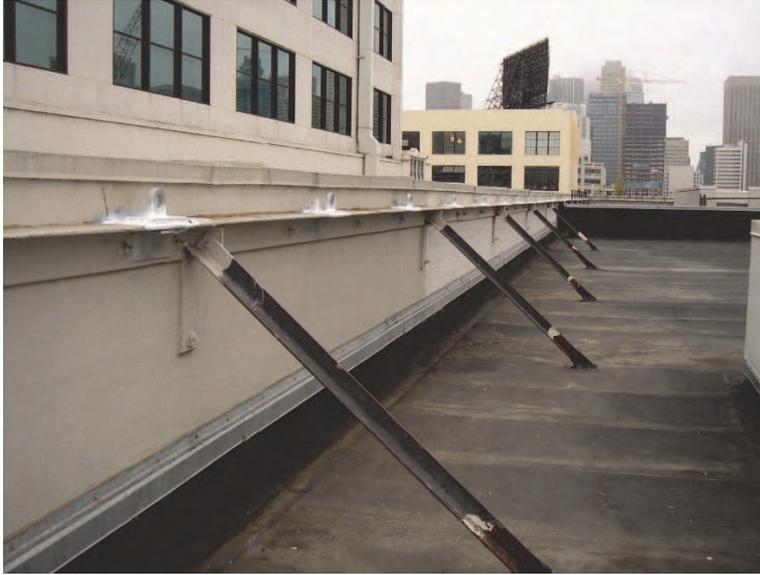
Figure 6-4 Example of parapet bracing (FEMA, 2012).

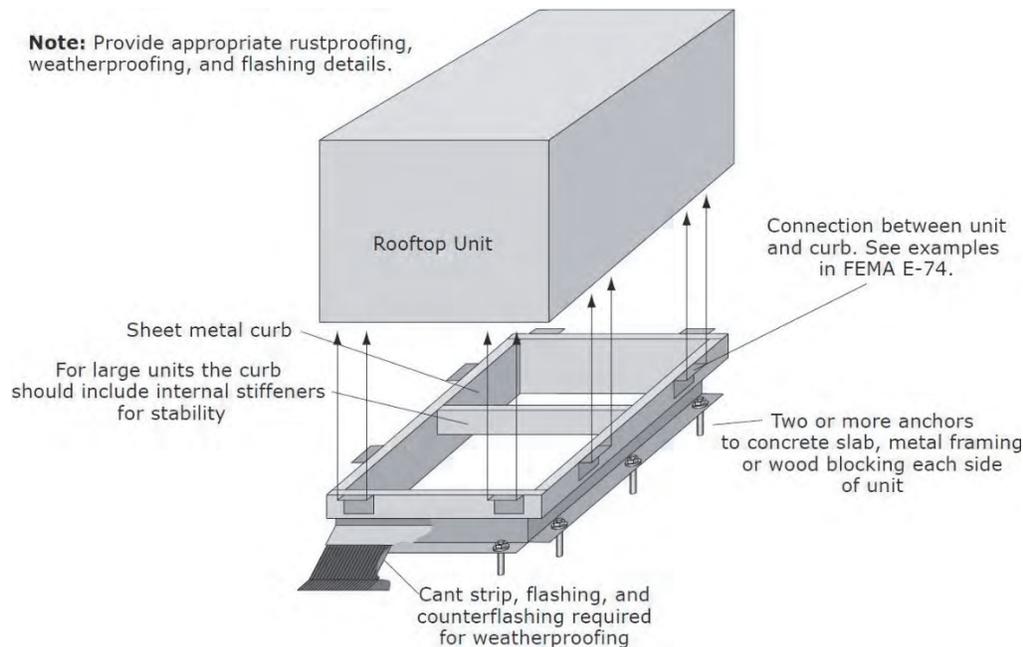
Figure 6-5 Example detail for roof-mounted HVAC unit (FEMA, 2012).

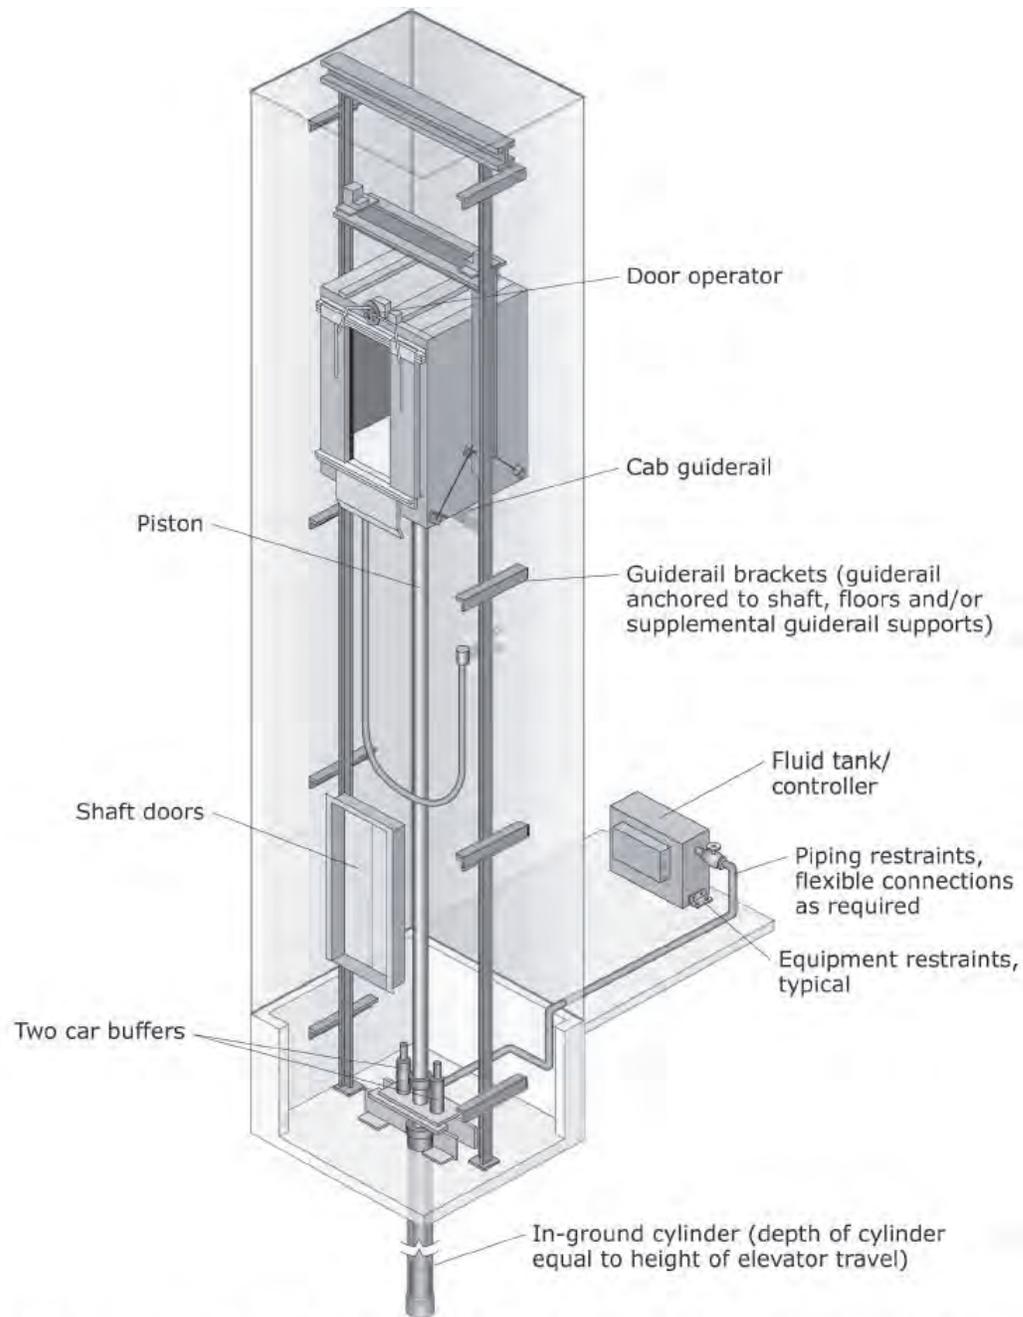
Notes: Provide lateral restraints for guiderails to resist design forces and accommodate anticipated interstory drift.
Elevators should be installed, maintained, inspected and repaired by qualified elevator technicians. Inappropriate seismic restraints may compromise the safe operation of these systems.

Figure 6-6 Bracing and anchorage details for hydraulic elevator guiderails (FEMA, 2012).

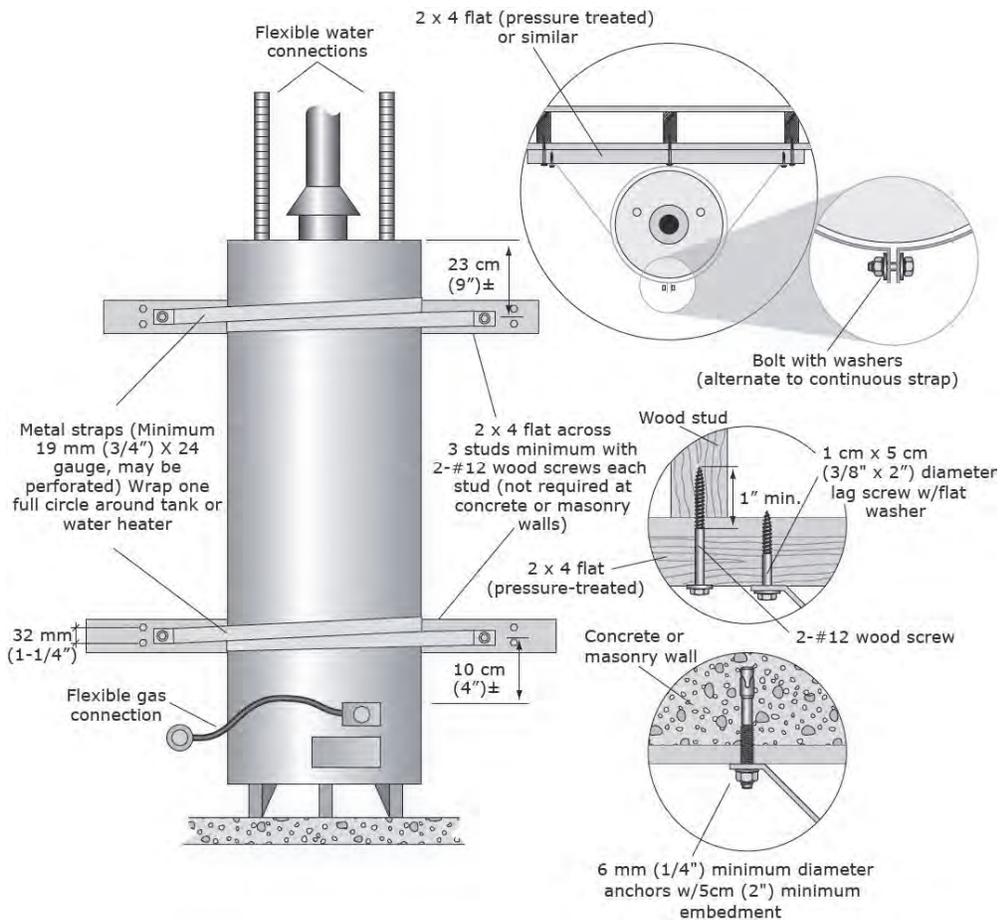
Figure 6-7 Suggested strapping details for bracing of a water heater (adapted from FEMA, 2012).

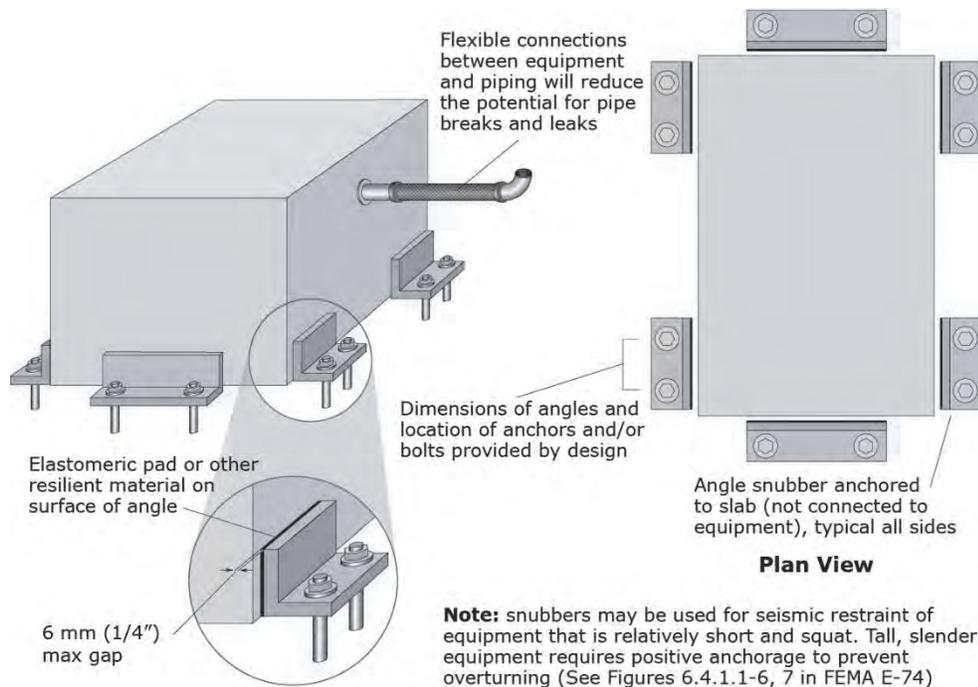
Figure 6-9 Example of anchorage for floor-mounted equipment restrained with snubbers (adapted from FEMA, 2012).

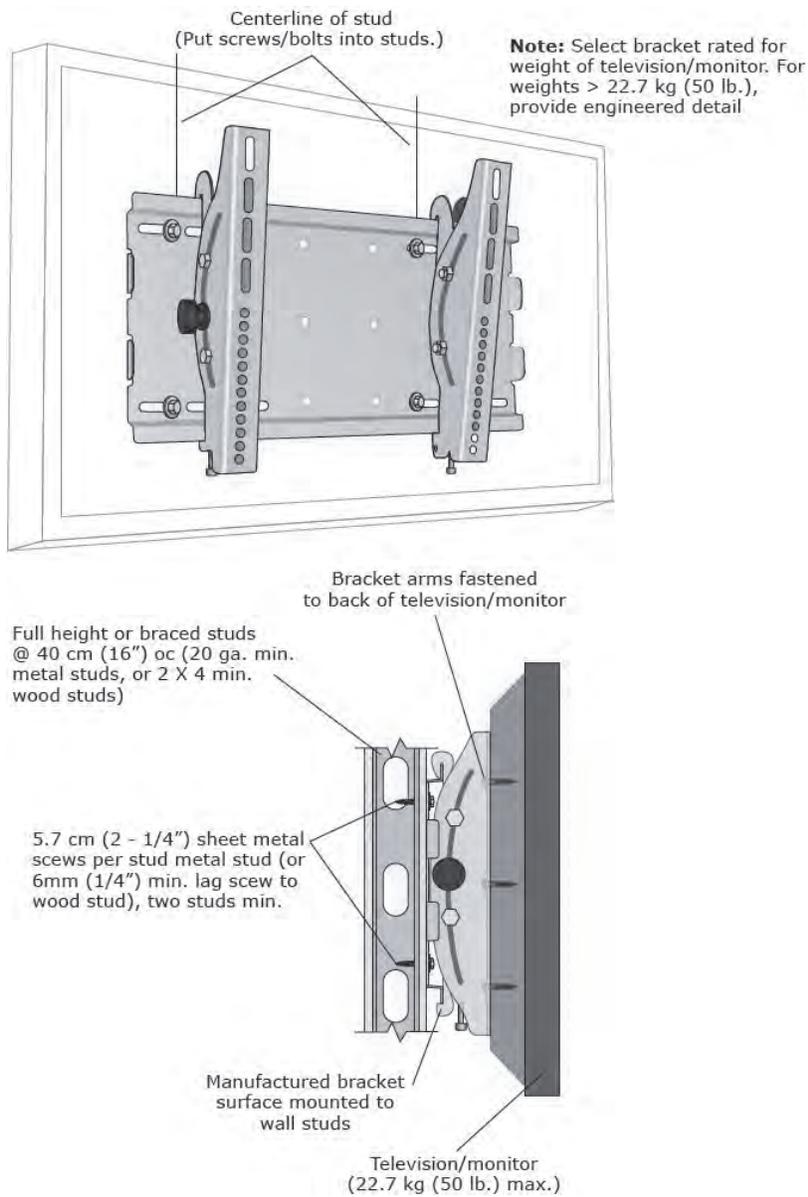
Figure 6-10 Example of earthquake mounting bracket for television monitors (adapted from FEMA, 2012).

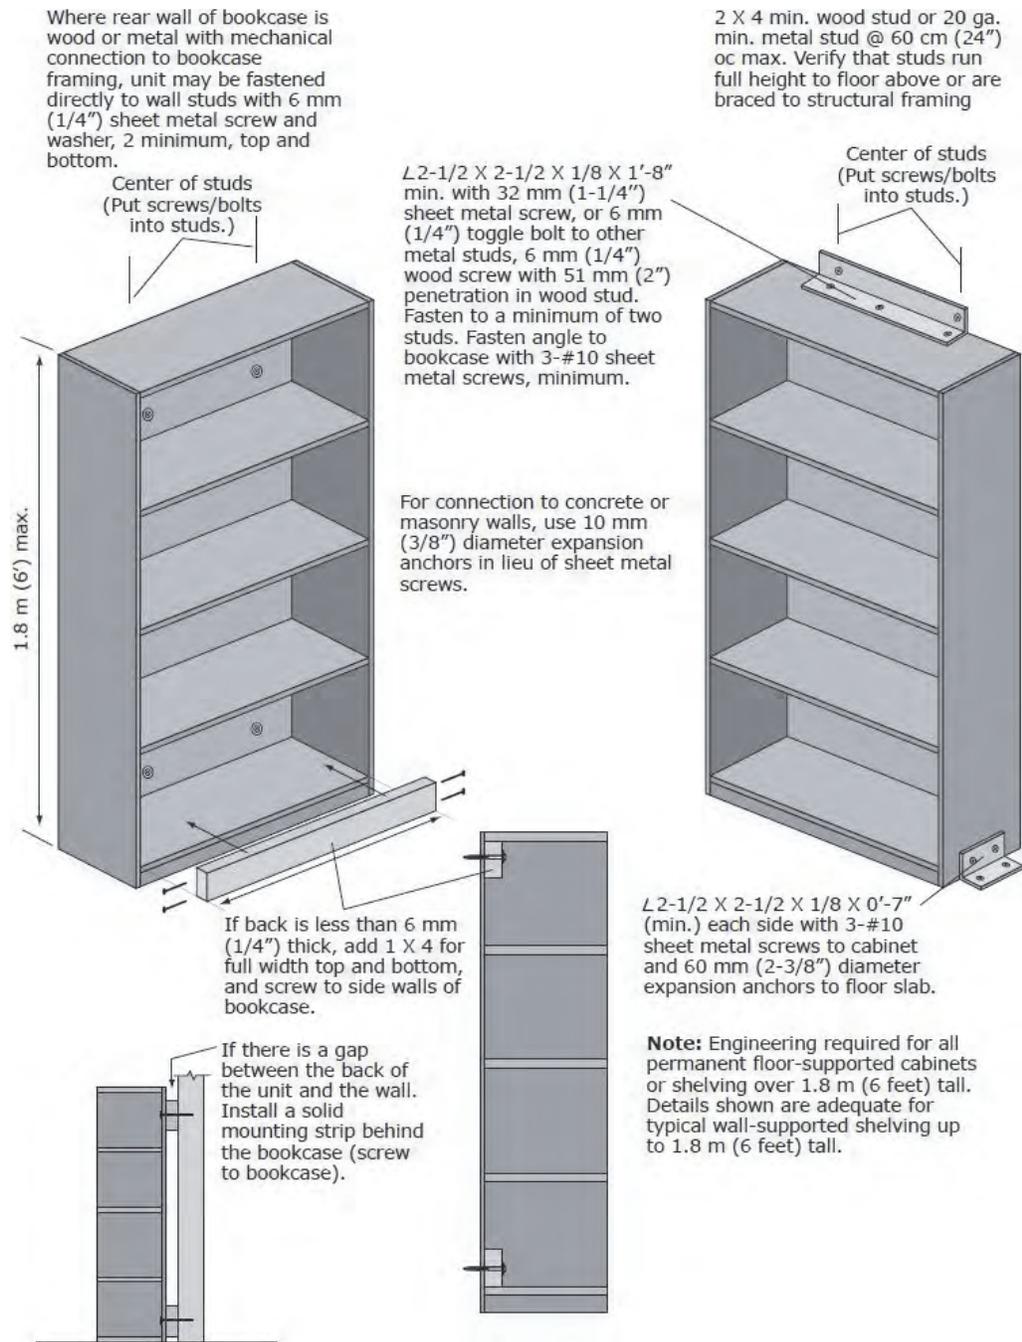
Figure 6-11 Example of bookshelf bracing and anchorage (adapted from FEMA, 2012).

Bookshelves frequently overturn in an earthquake unless they are properly anchored. Bookshelves taller than 1.2 meters in height must be anchored to prevent overturning, which is a requirement in ASCE/SEI 41-06 (ASCE, 2006) when the performance objective is life safety or higher. Figure 6-11 illustrates an example for bookshelf bracing and anchorage. More details on bracing of bookshelves and shelving can be found in Section 6.5.2 of FEMA E-74 (FEMA, 2012).
