Guidelines for the Seismic Retrofit of Existing Schools and Design of New Schools in the Republic of Armenia

APPLIED TECHNOLOGY COUNCIL

June 2017

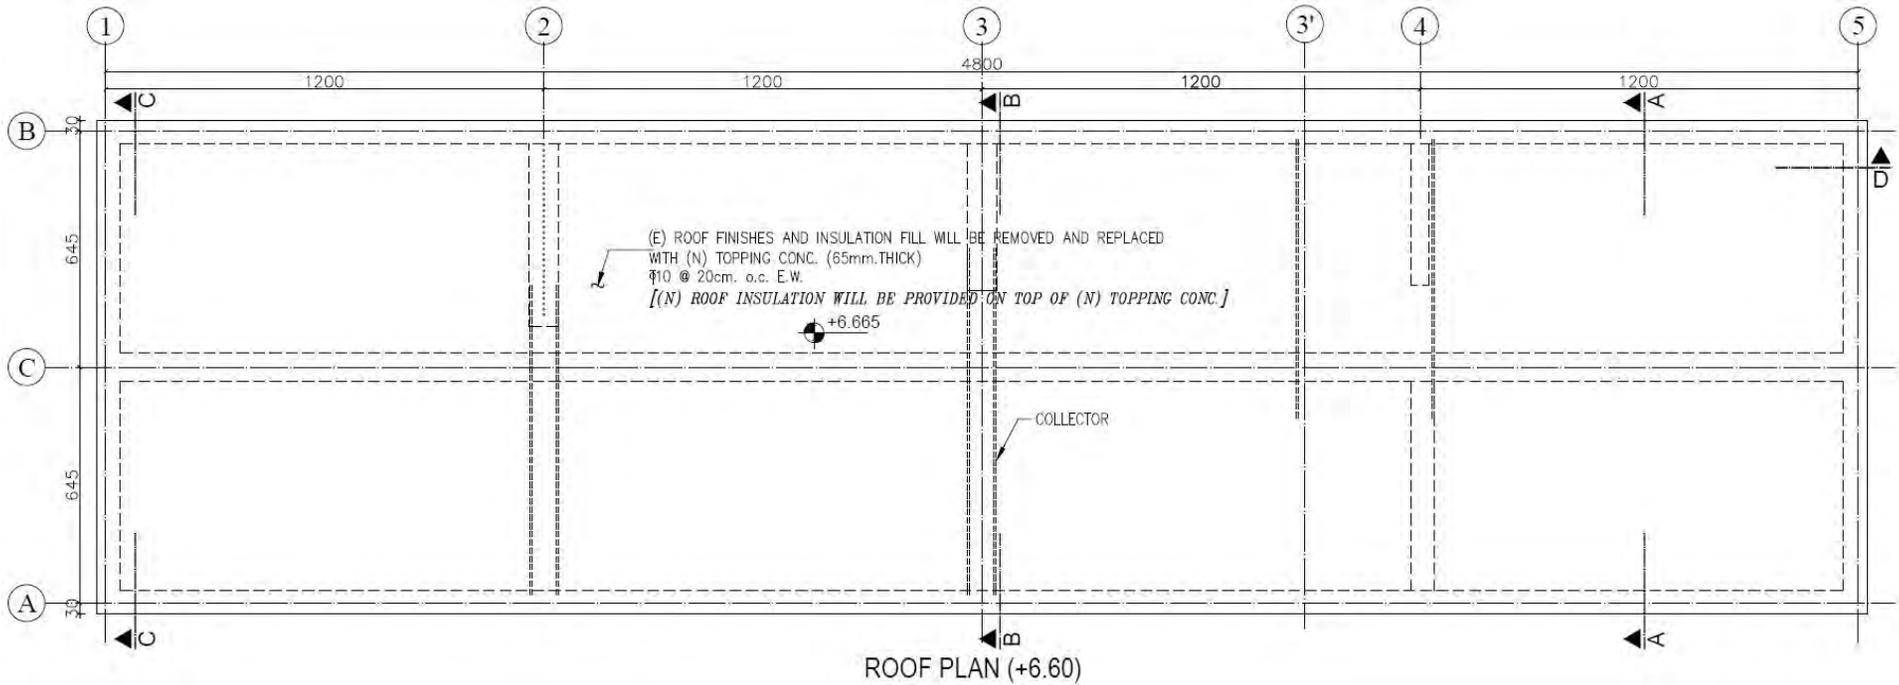
Figure B-4 Typology A typical classroom - roof plan.

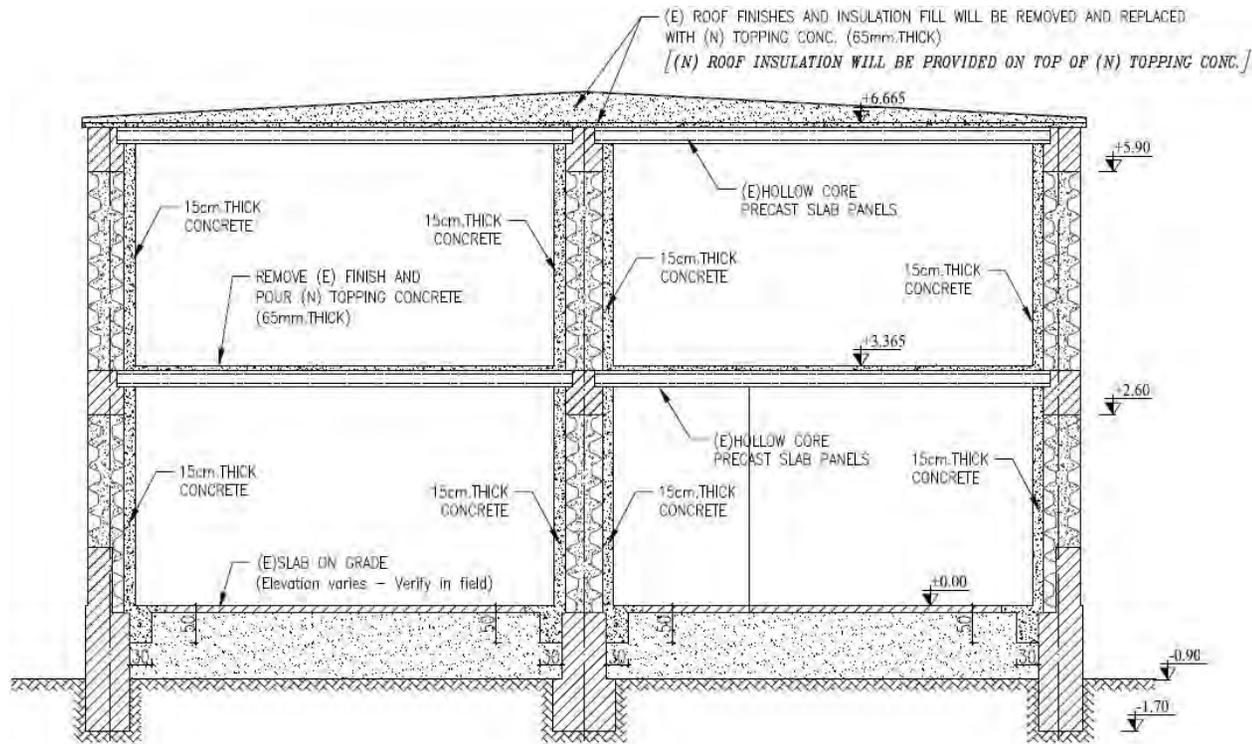
SECTION A-A
(TYPICAL)

Figure B-5 Typology A typical classroom - transverse section.

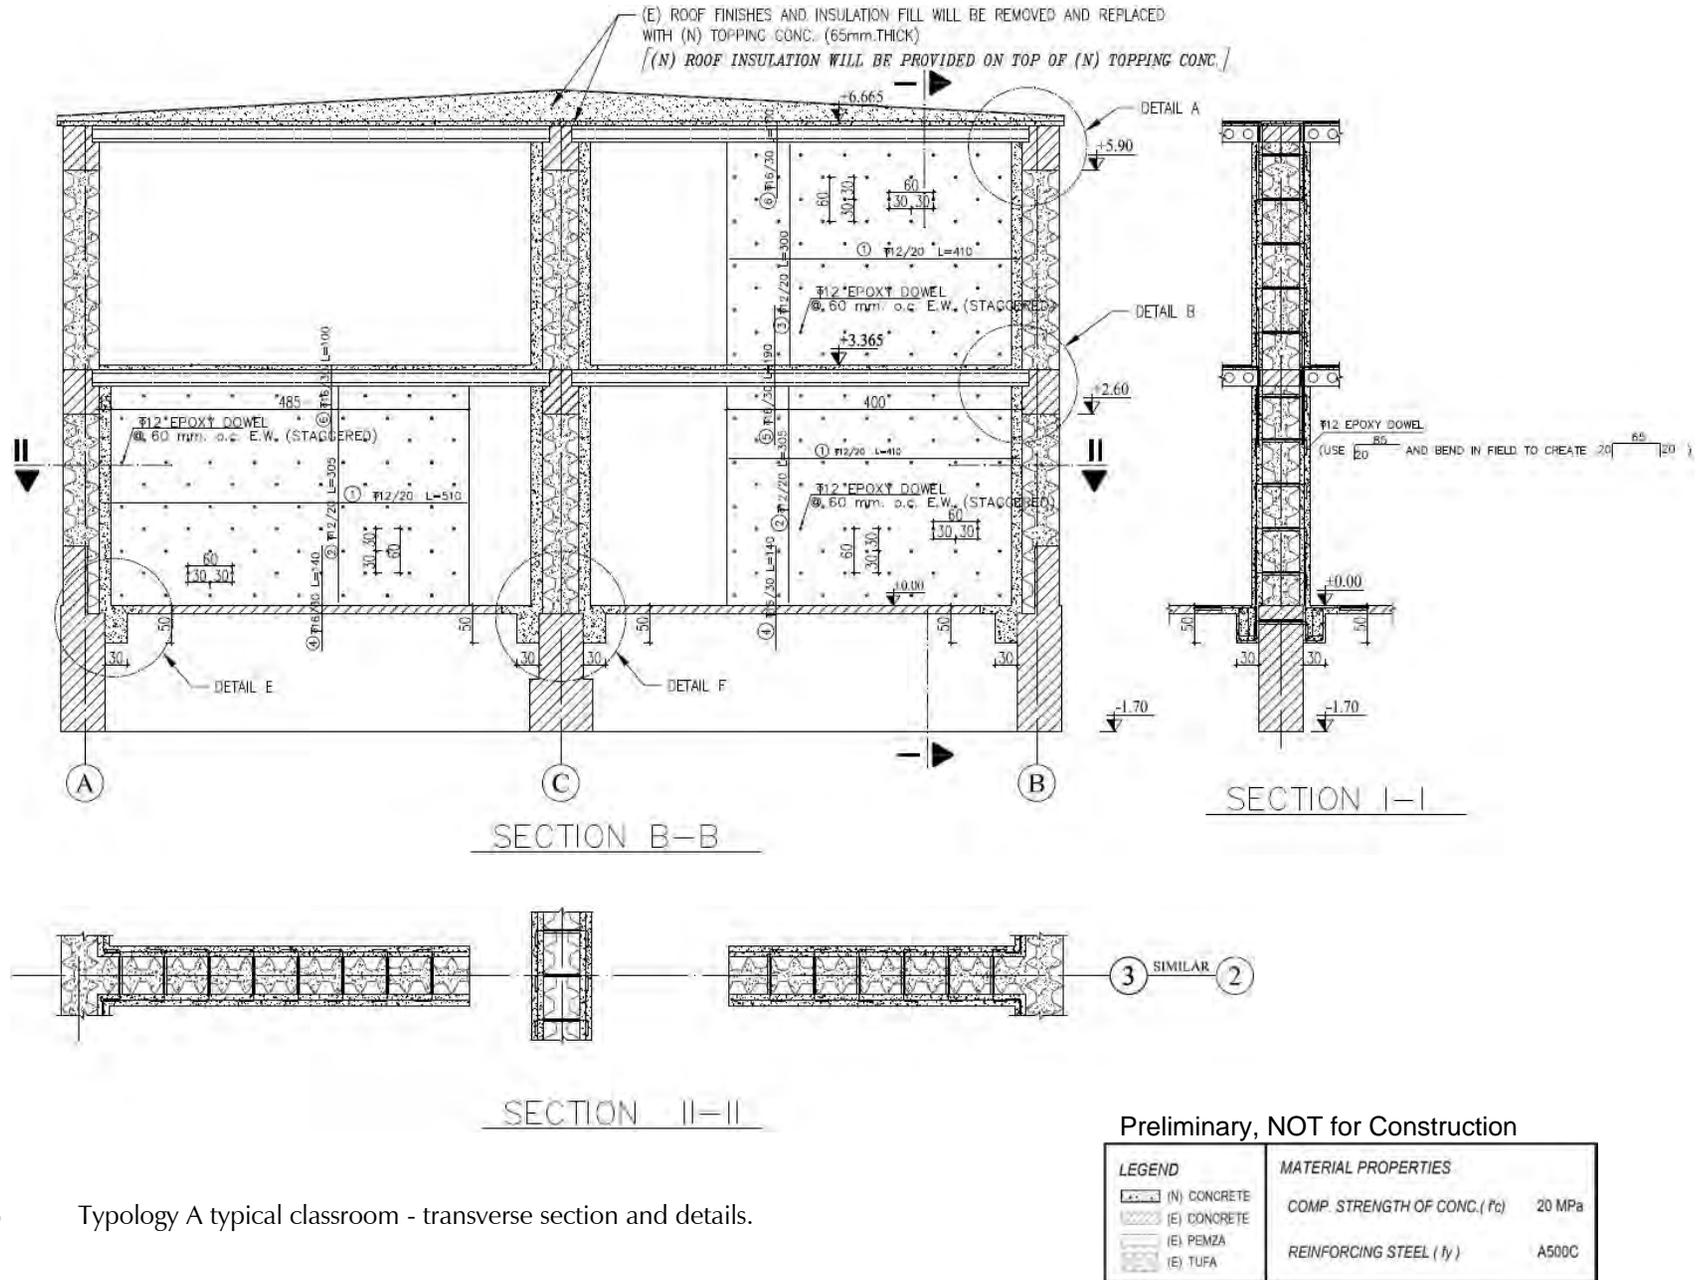
Figure B-6 Typology A typical classroom - transverse section and details.

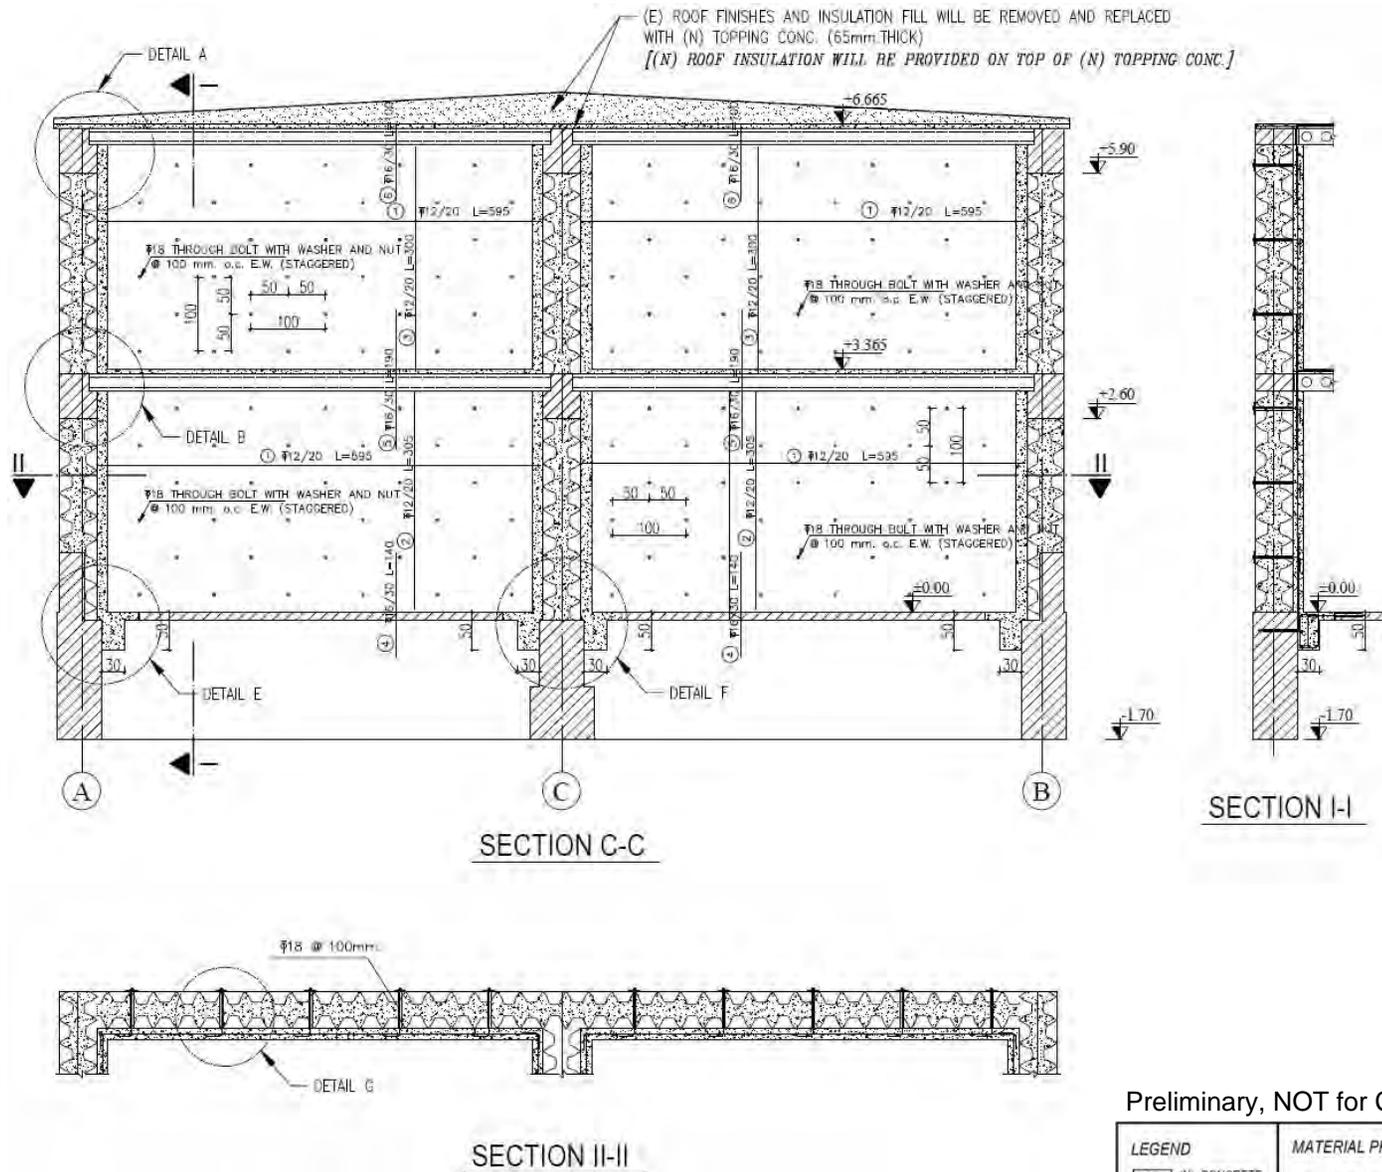
Figure B-7 Typology A typical classroom - transverse section and details.

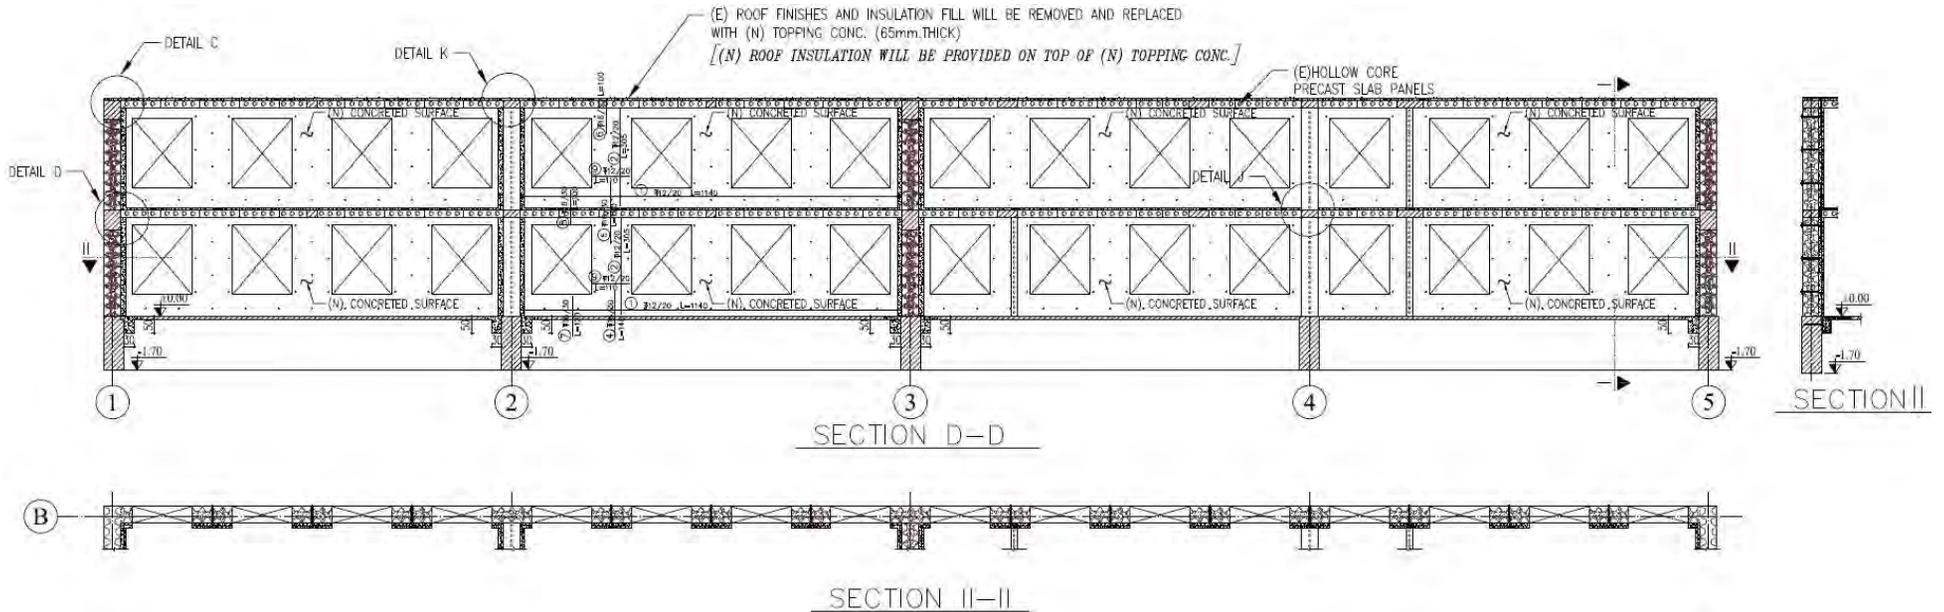
Figure B-8 Typology A typical classroom - longitudinal section and details.

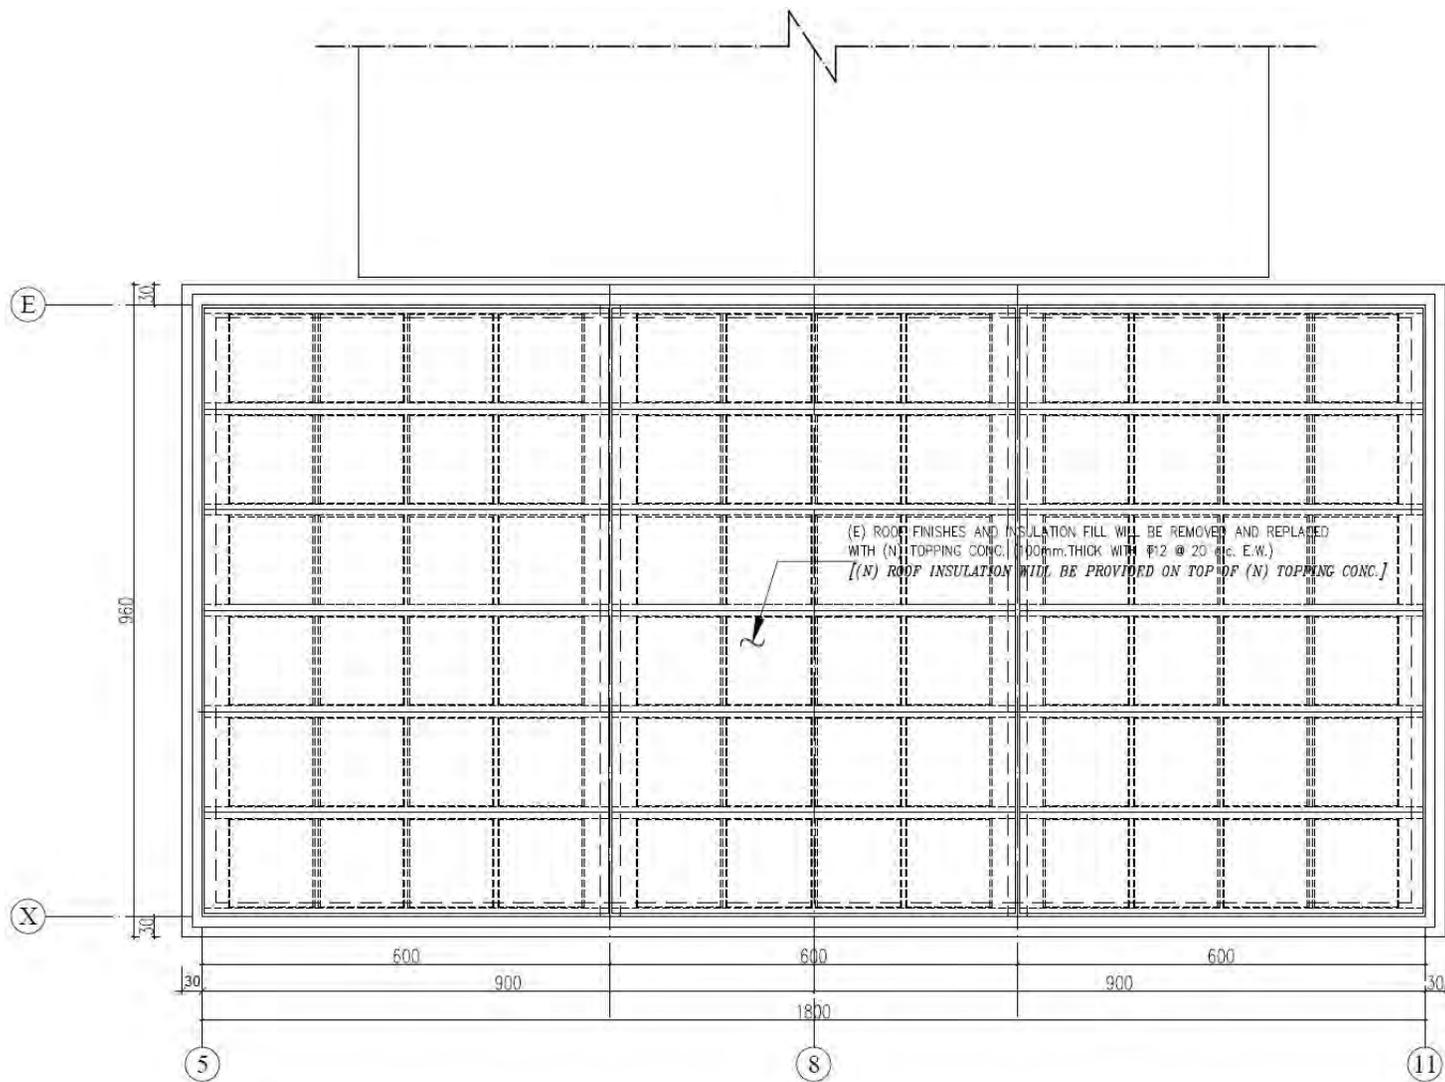
ROOF PLAN (+6.60)

Figure B-13 Typology A typical gymnasium - roof plan.

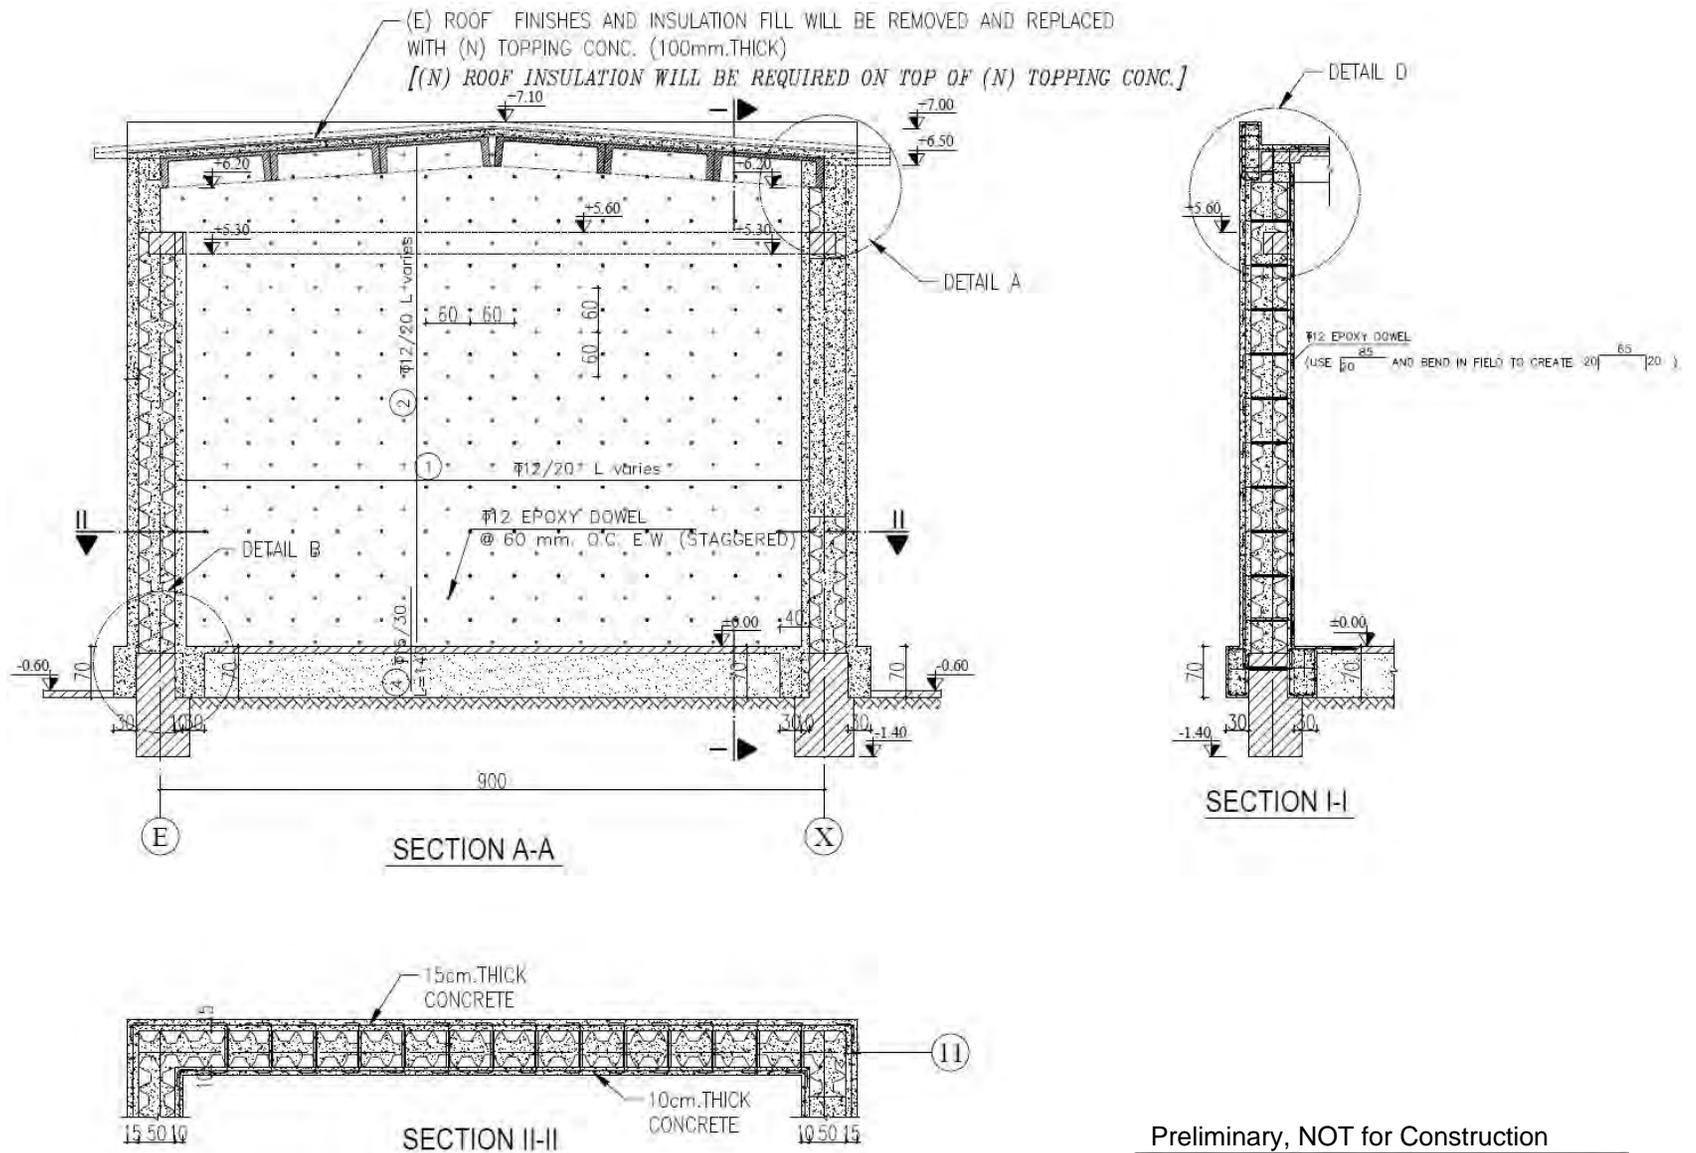
Figure B-14 Typology A typical gymnasium - transverse section and details.

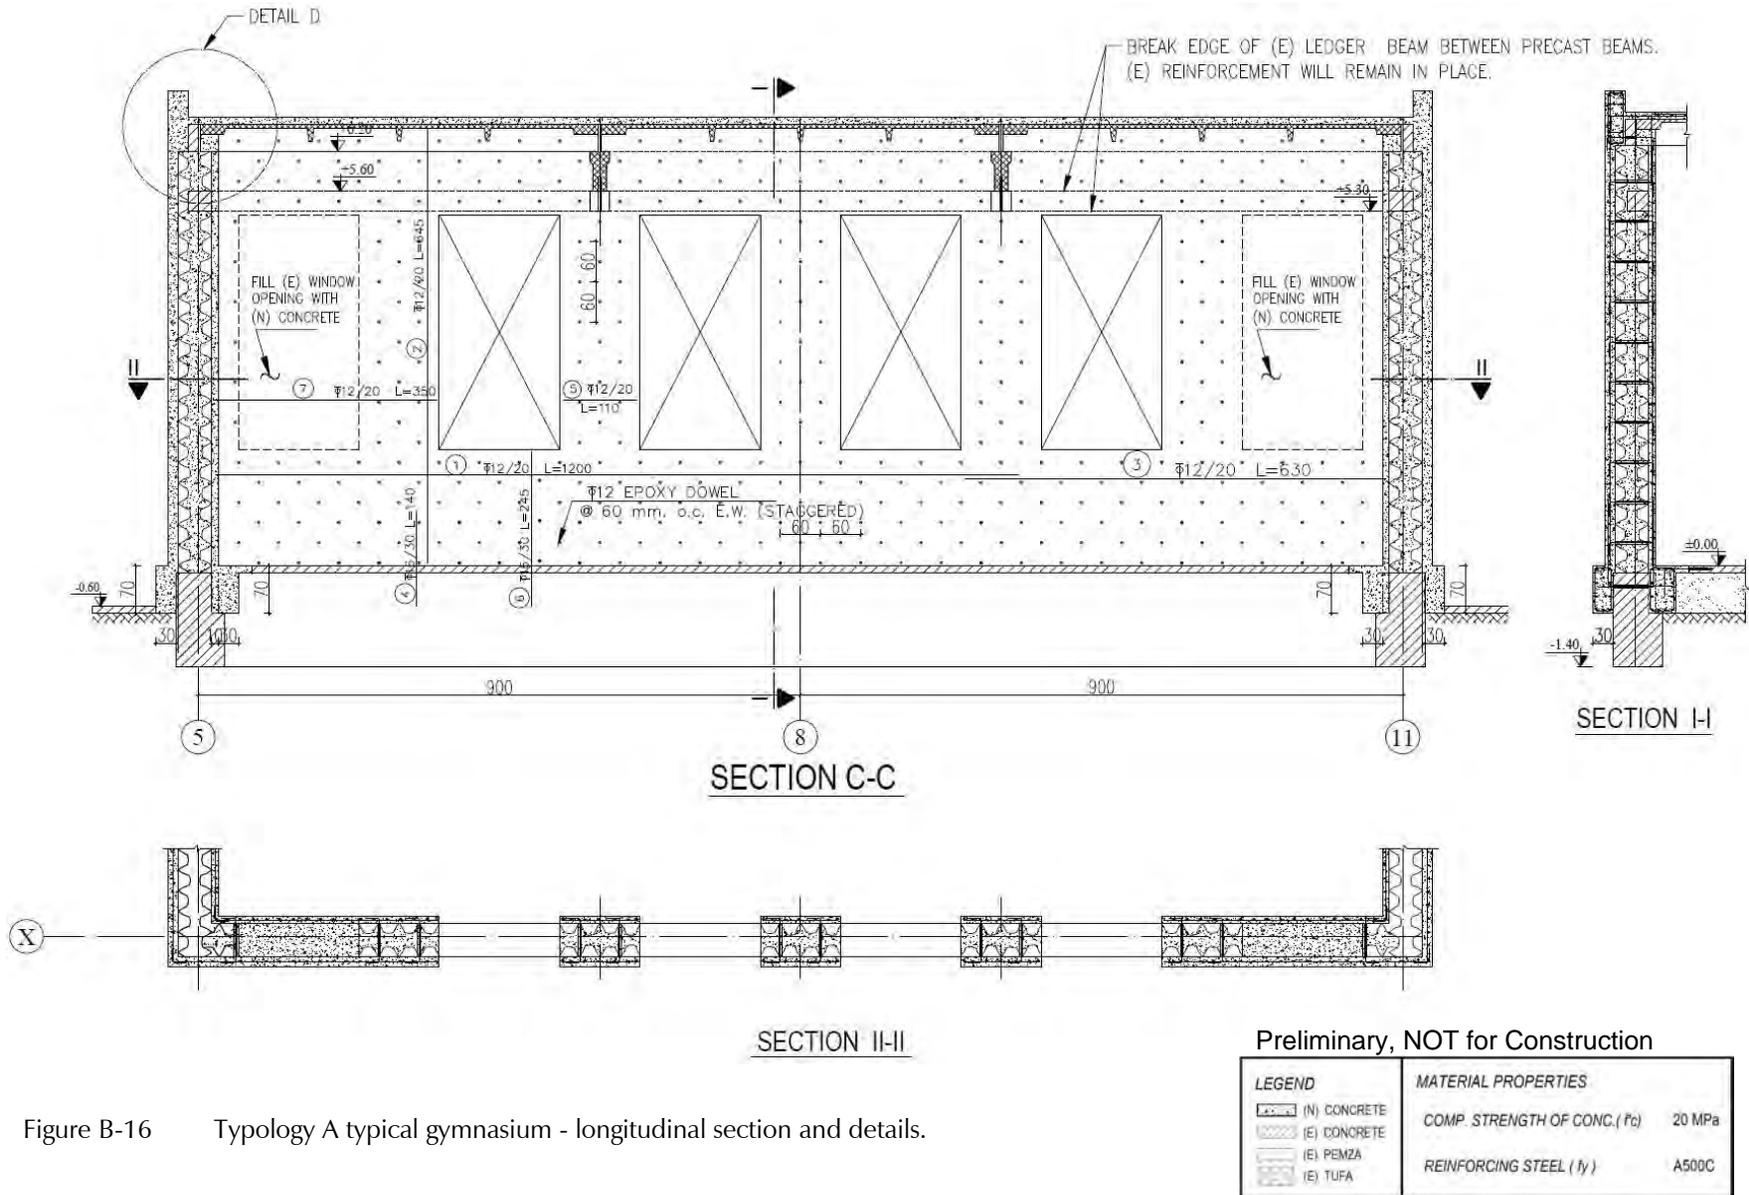
Figure B-16 Typology A typical gymnasium - longitudinal section and details.

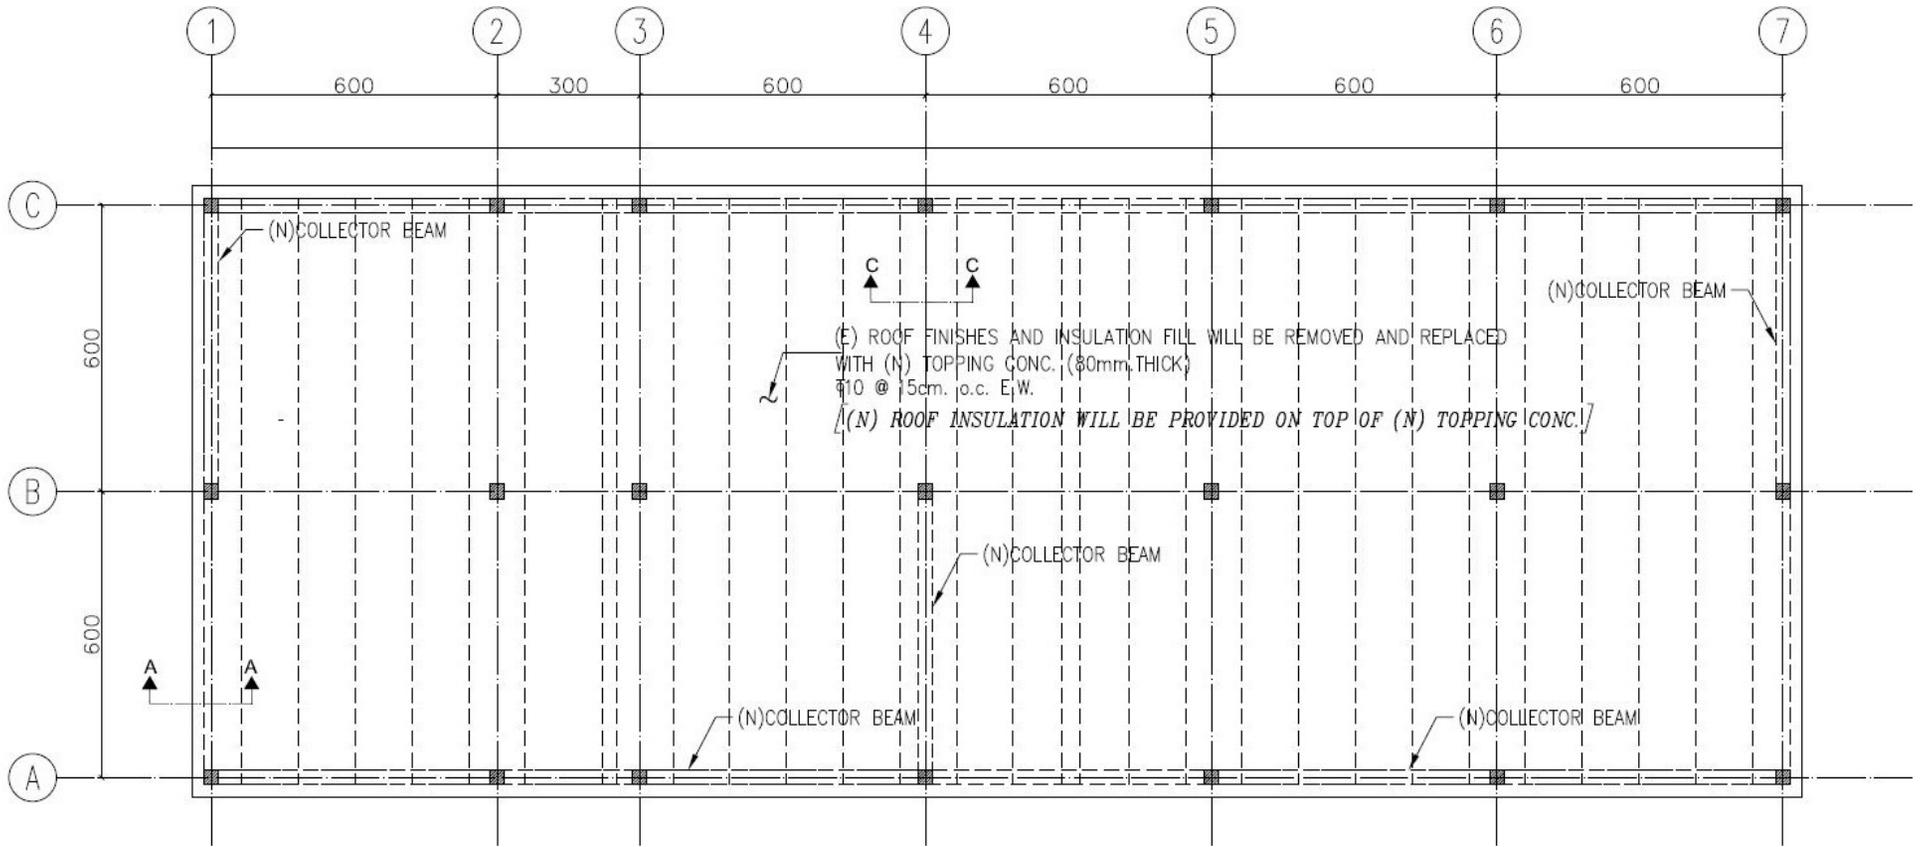
ROOF PLAN (+6.68) Preliminary, NOT for Construction

Figure C-4 Typology D-1 typical classroom - roof plan.

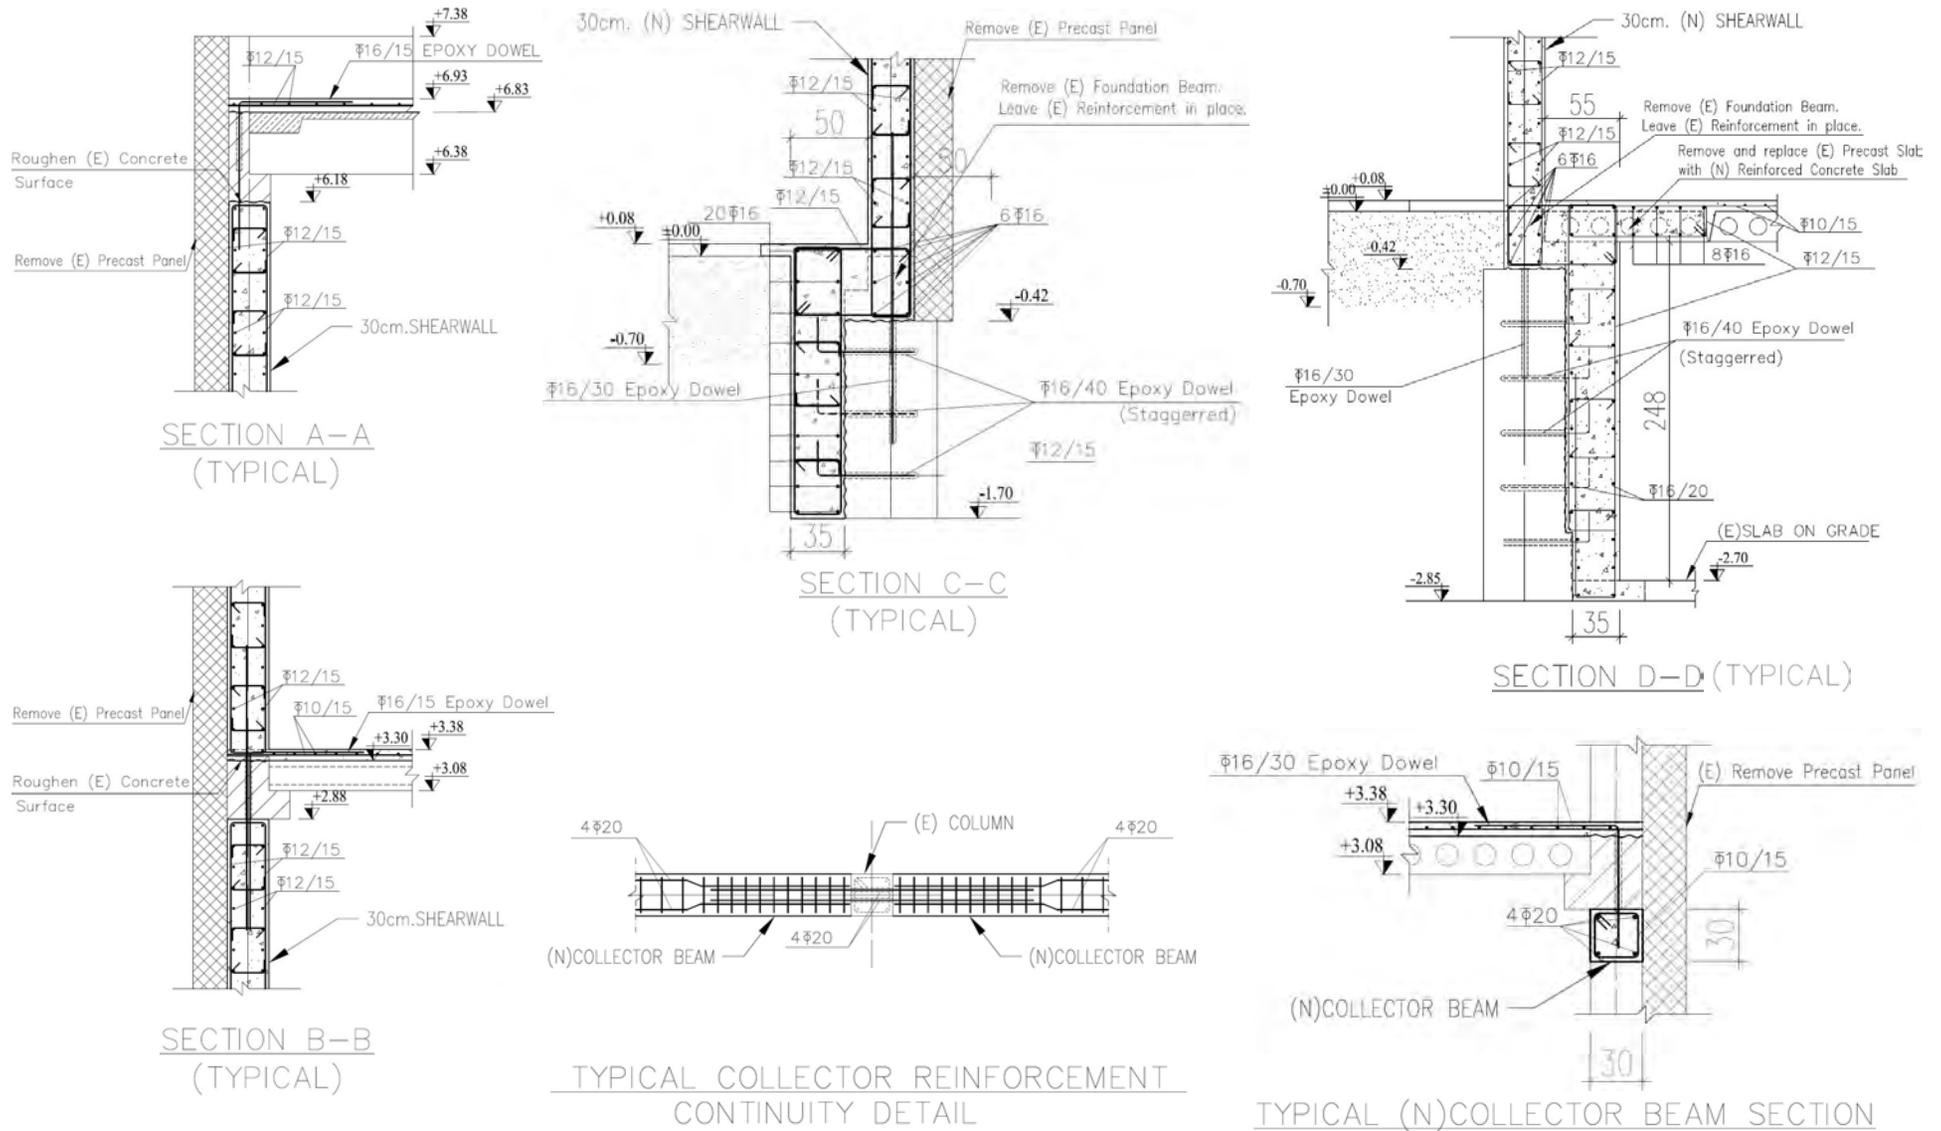
Figure C-10 Typology D-1 typical gymnasium - typical details.

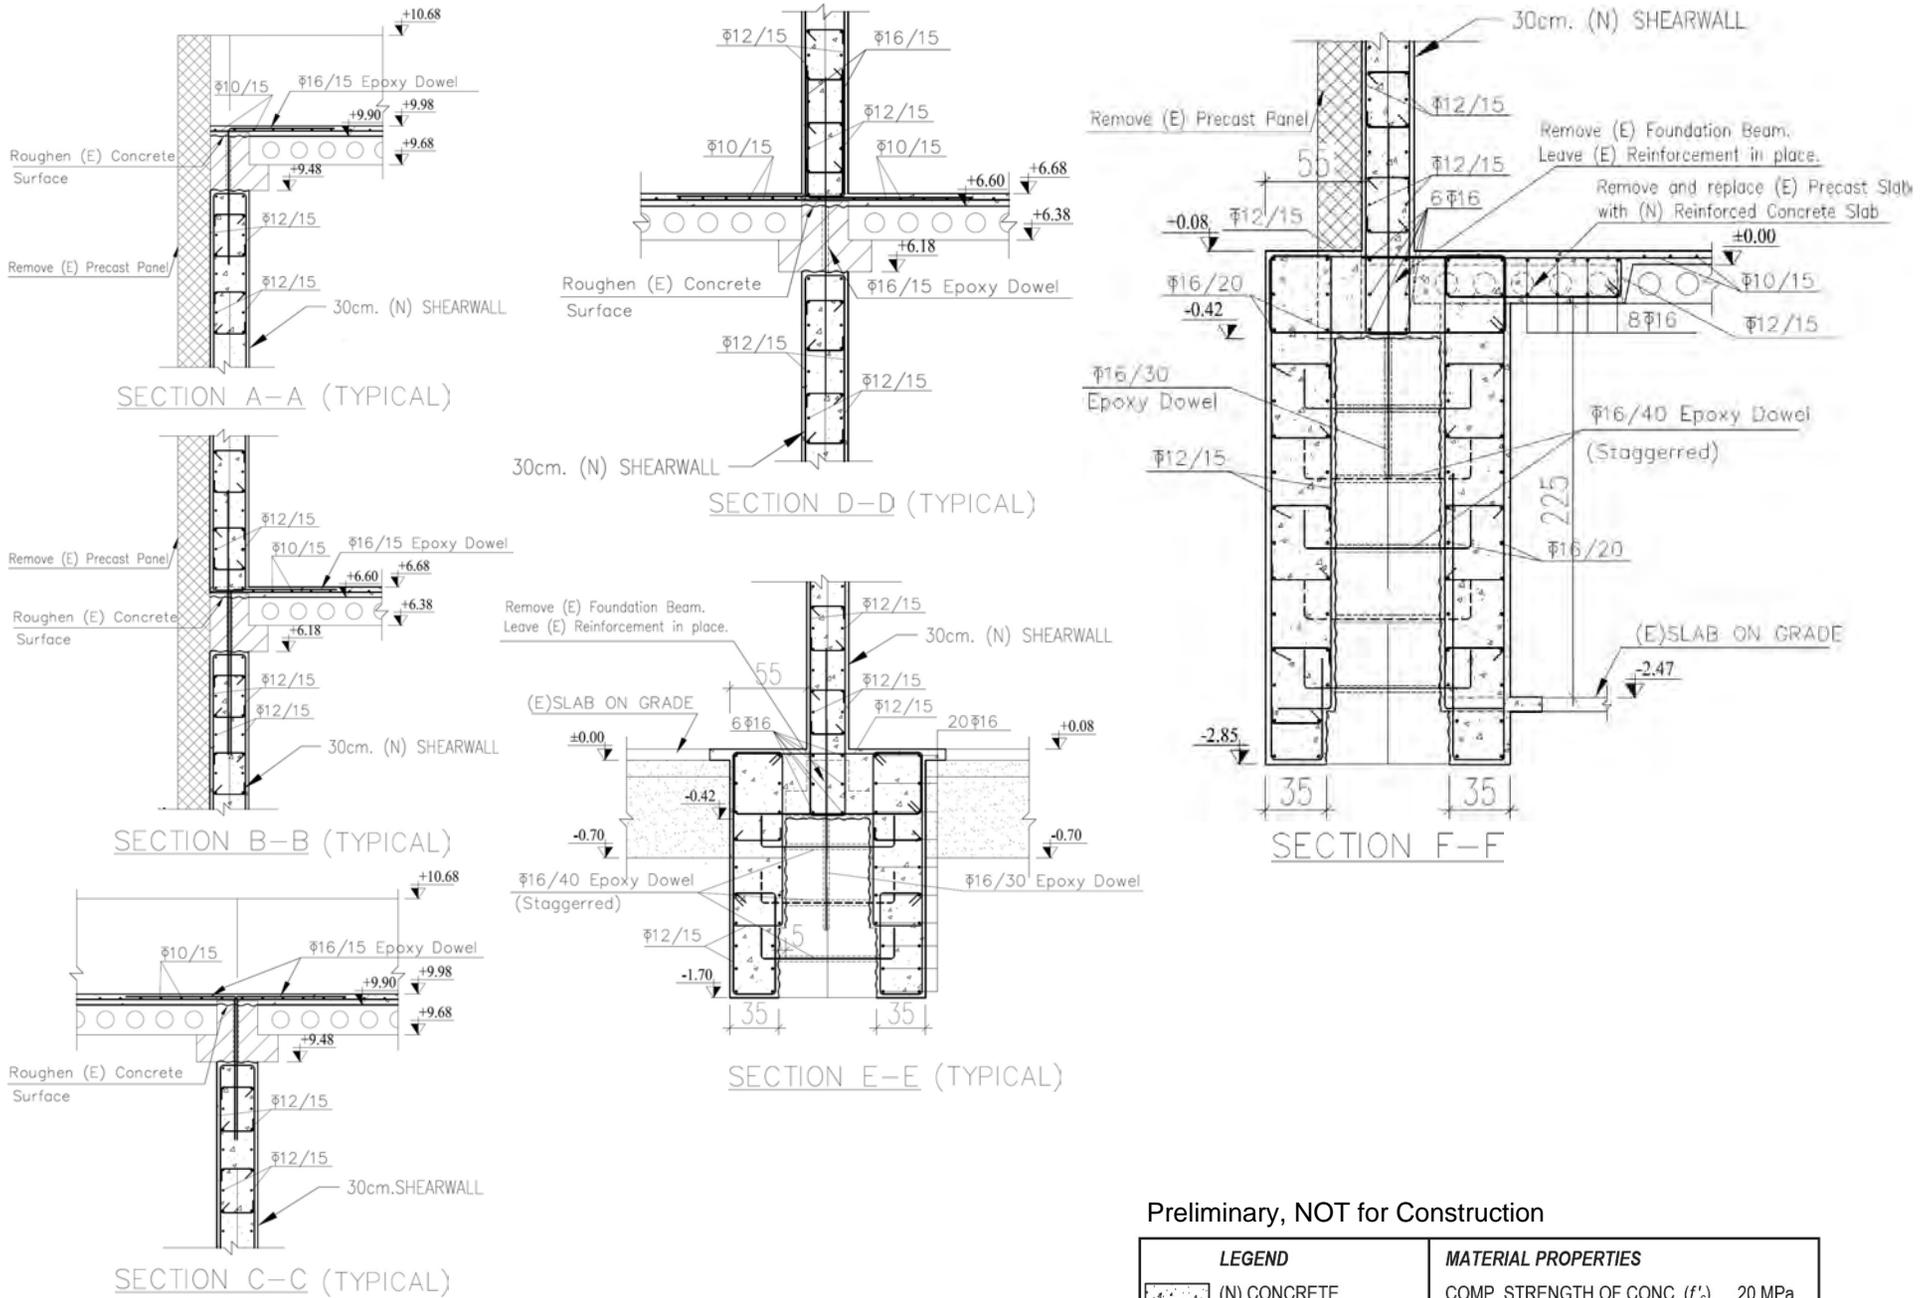
Figure D-6 Typology D-2 typical classroom - typical details.

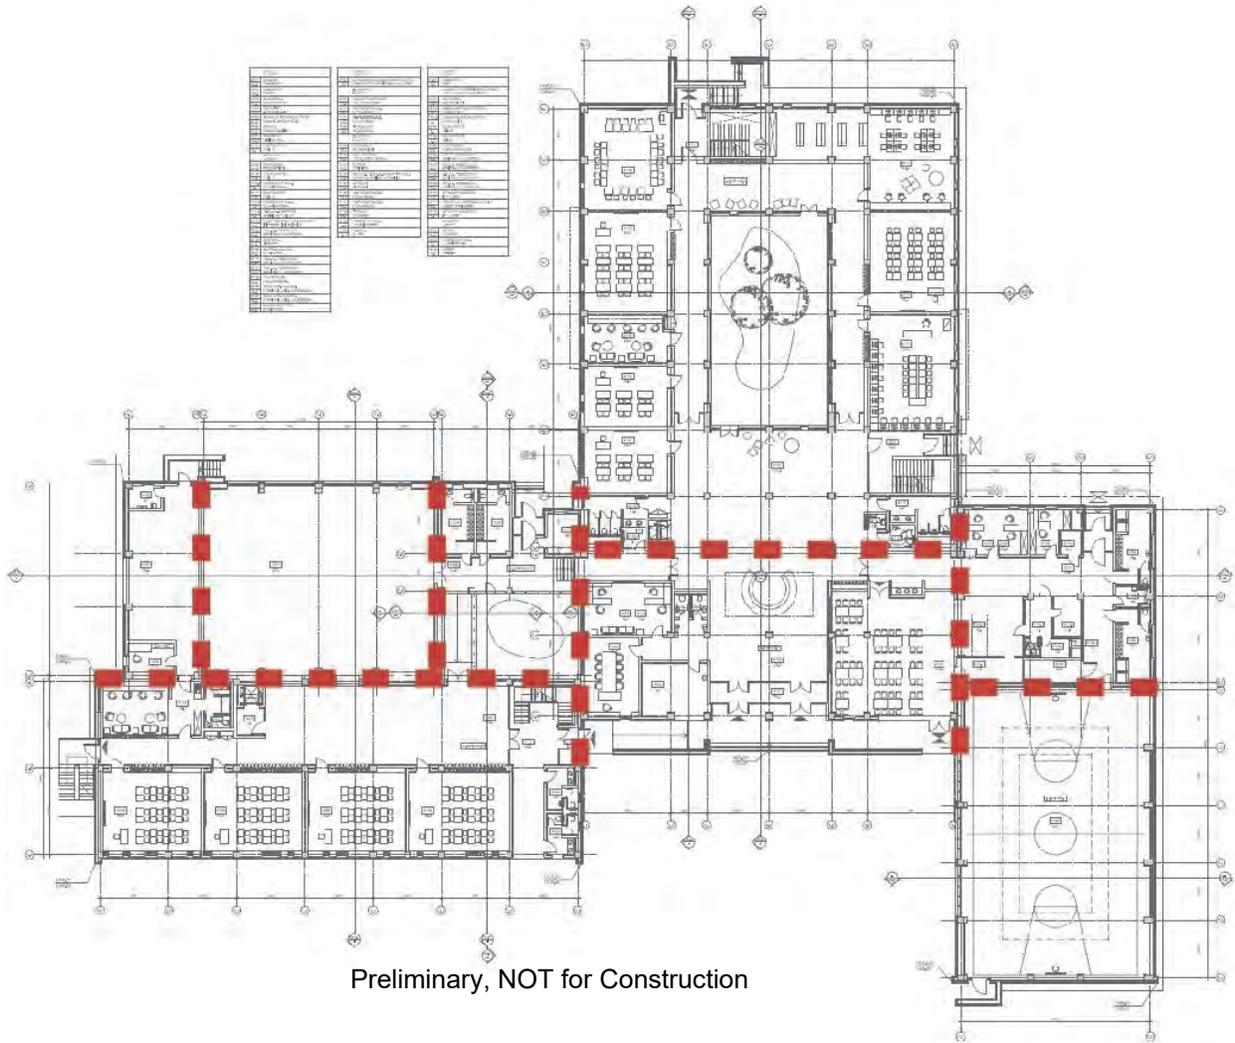
Figure E-1 Ground floor plan of UNDP prototypical new school. Dashed lines indicate locations of anti-seismic joints for structural separation between modules.

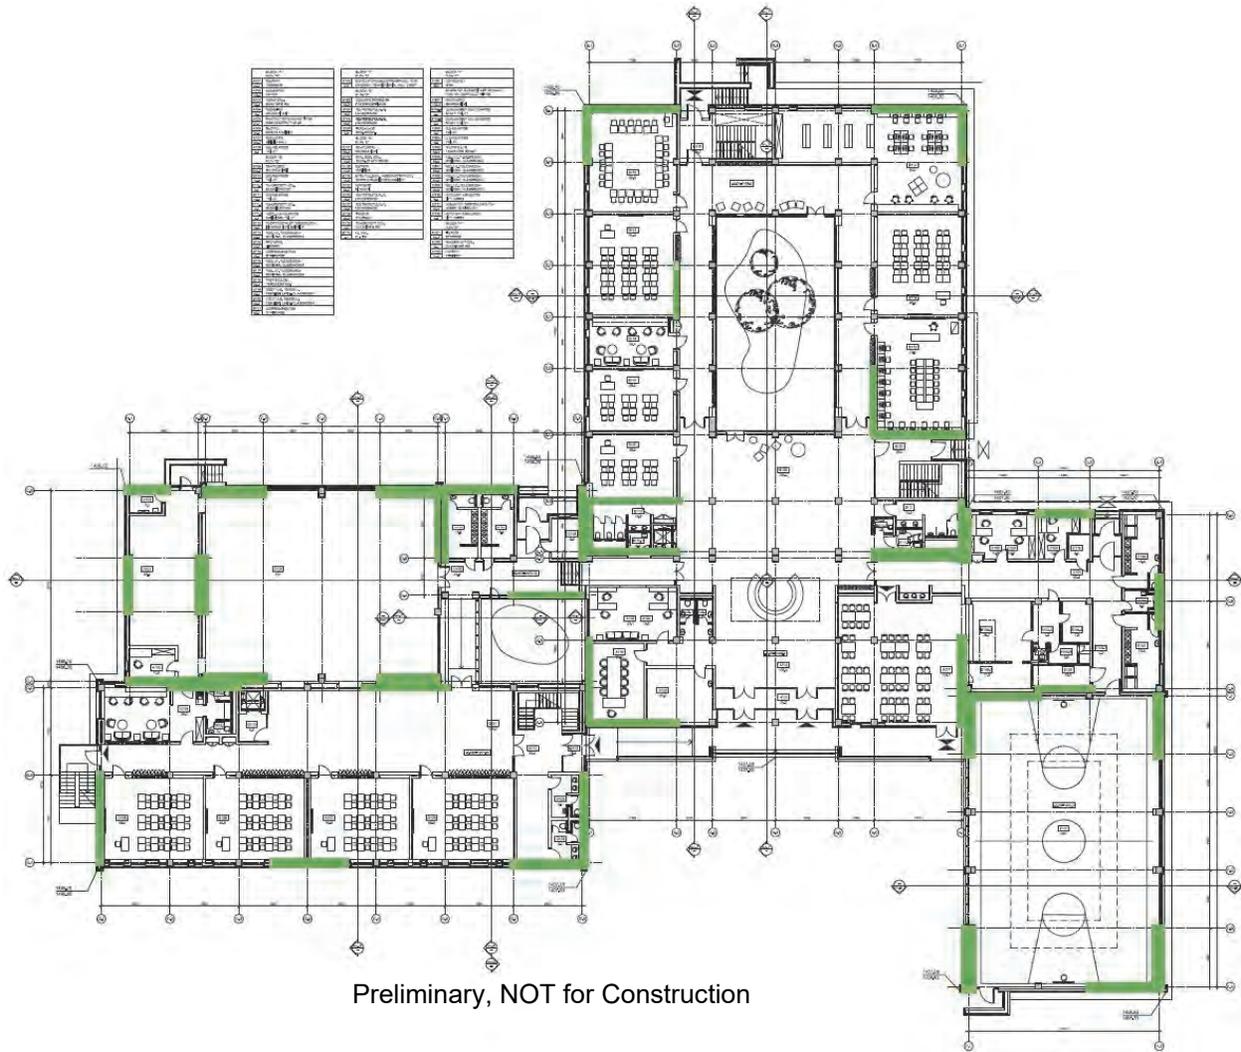
Figure E-2 Ground floor plan of UNDP prototypical new school. Heavy lines indicate conceptual locations of concrete shear walls.
