Guidelines for the Seismic Retrofit of Existing Schools and Design of New Schools in the Republic of Armenia

APPLIED TECHNOLOGY COUNCIL

June 2017

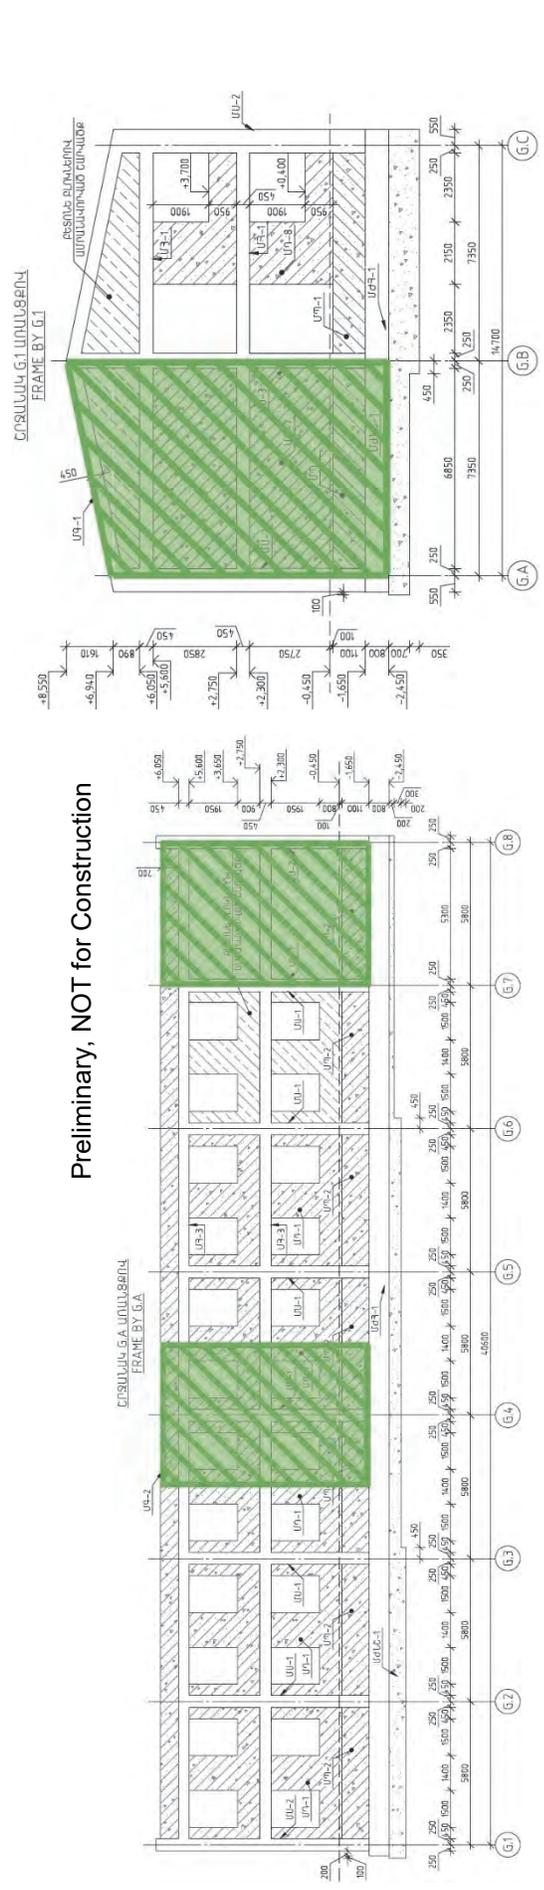
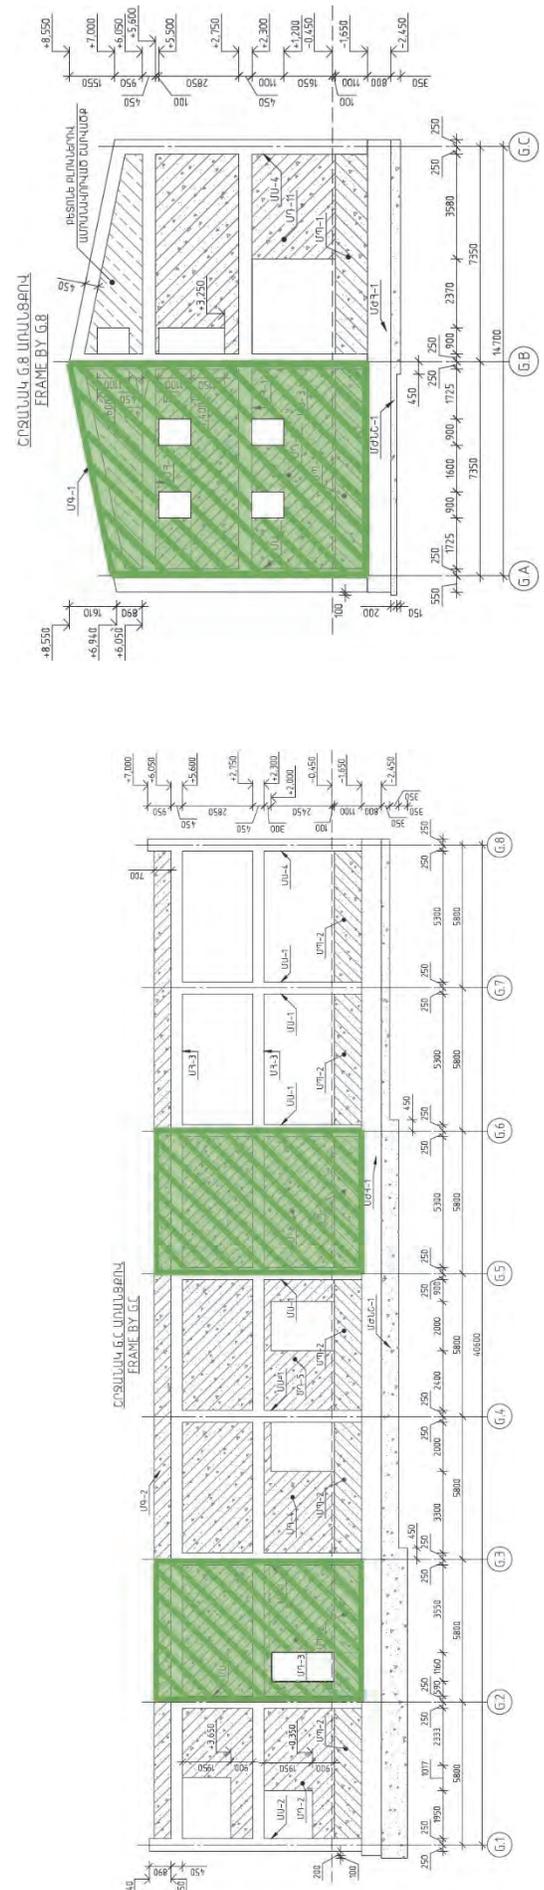
Figure E-3 Structural elevations at classroom modules of UNDP prototypical new school. Highlighted bays indicate conceptual locations of concrete shear walls.

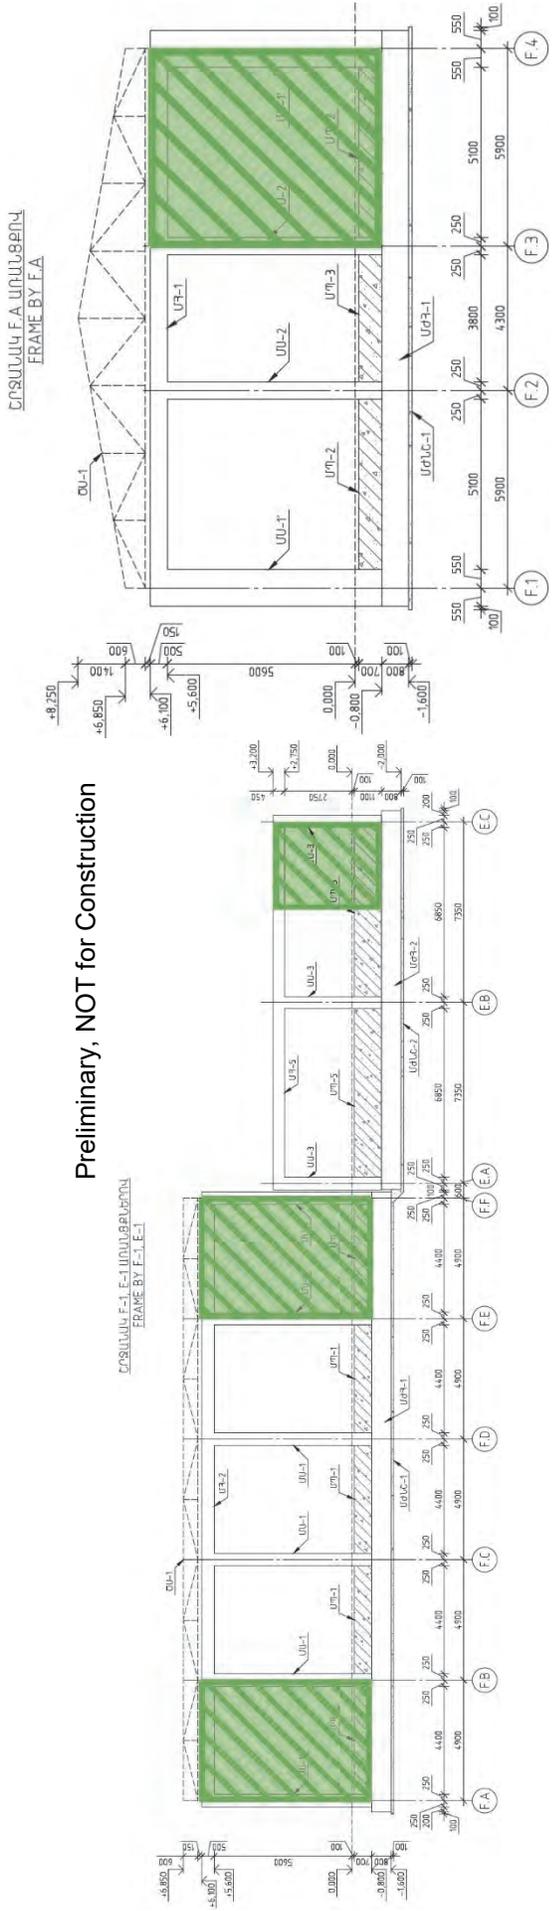
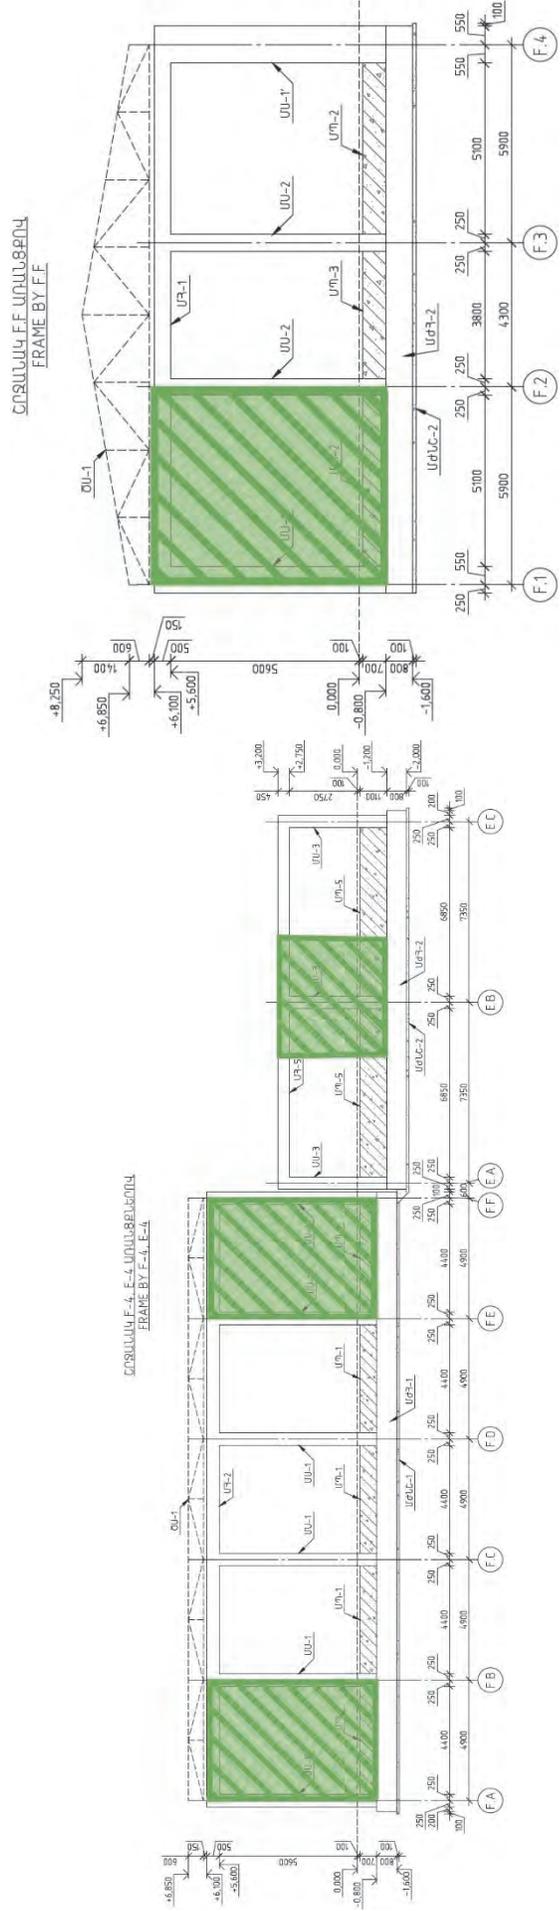
Figure E-4 Structural elevations at gymnasium modules of UNDP prototypical new school. Highlighted bays indicate conceptual locations of concrete shear walls.

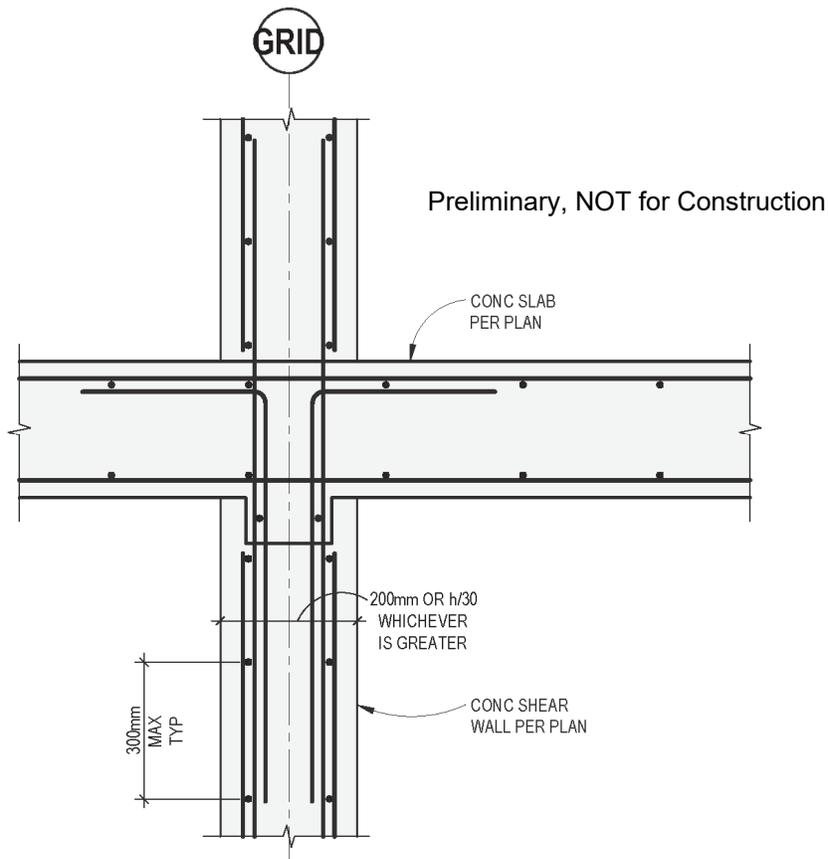
Figure E-5 Conceptual detail of reinforced concrete shear walls at intermediate floor or roof slabs (courtesy of MHP Structural Engineers).

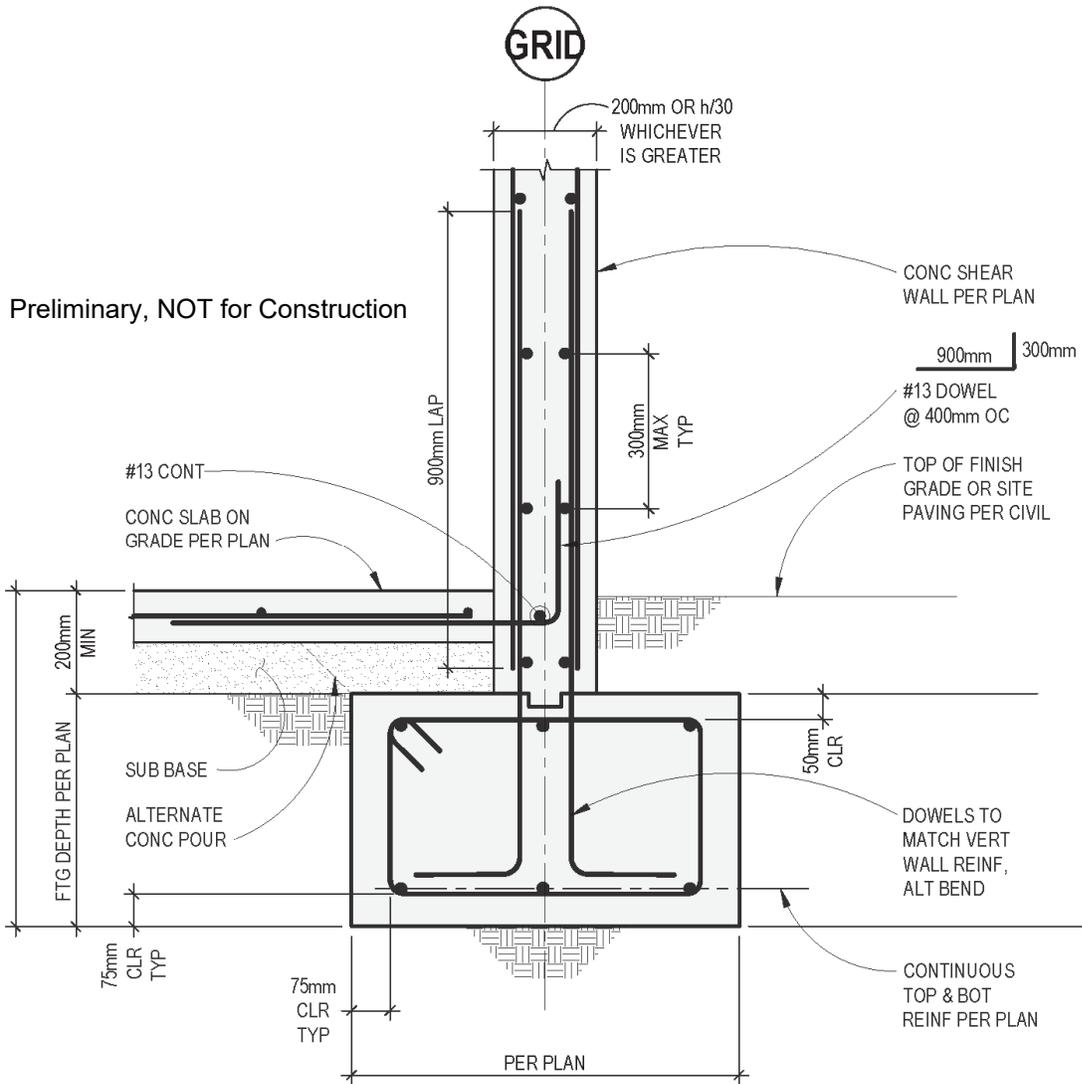
Figure E-6 Conceptual detail of reinforced concrete shear walls at foundation (courtesy of MHP Structural Engineers).

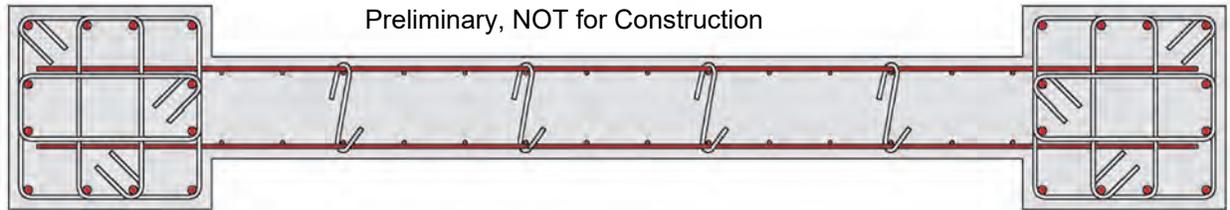
Figure E-7 Conceptual plan detail of reinforced concrete shear walls at boundary columns (courtesy of MHP Structural Engineers).

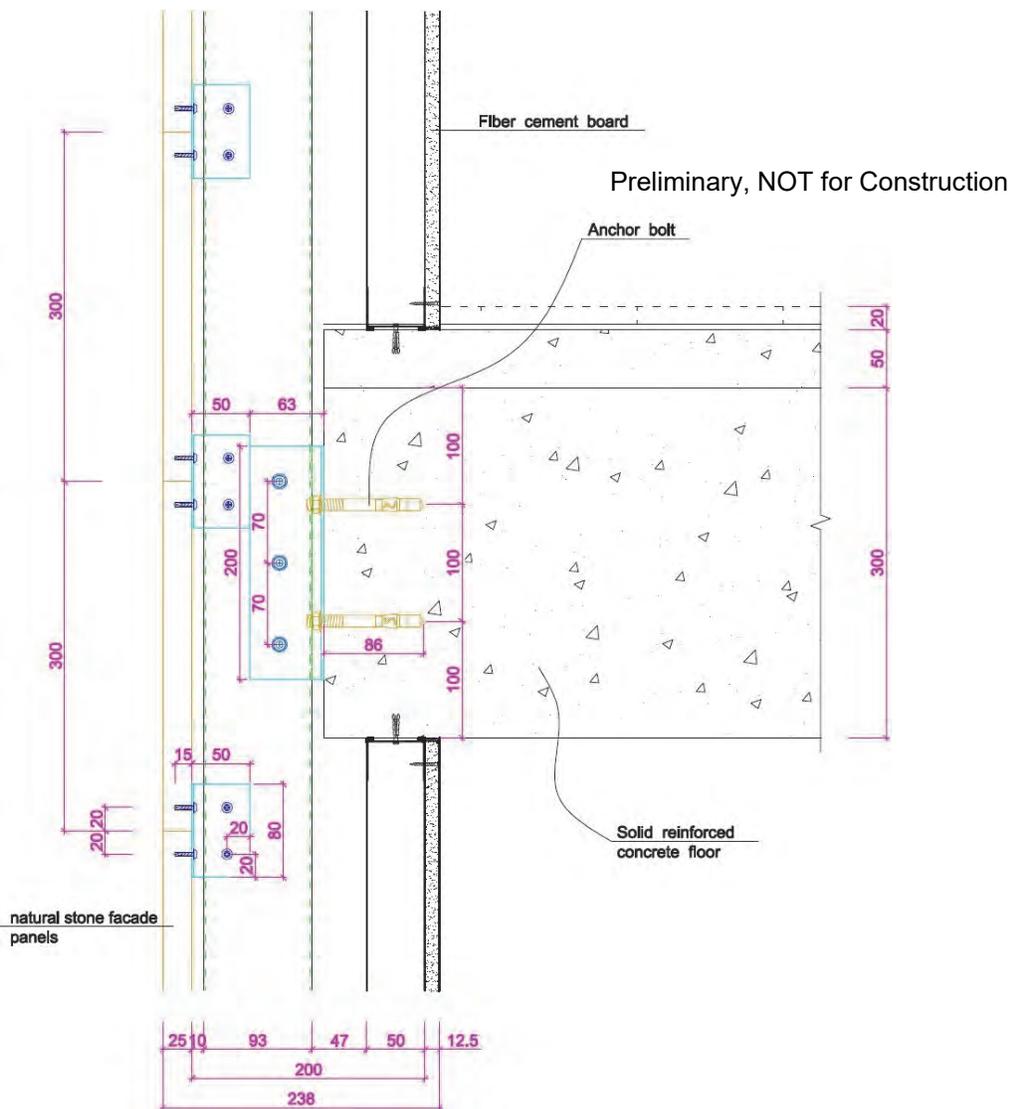
Figure E-8 Conceptual detail of exterior closure walls.
